Tookany Creek Watershed Management Plan Steering Committee

Tookany Creek Watershed Management Plan Goals

Visual Streambank Assessment

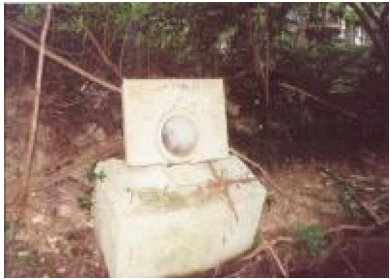
1. Dislodged/eroded drainage pipe behind Oak Summit Apartments (right bank)
Action/BMP: Repair stormwater pipe

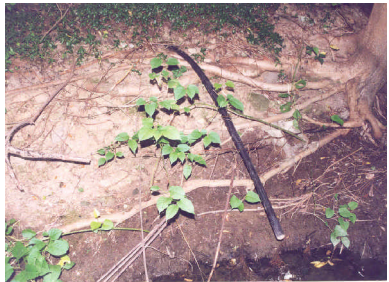
2. Unknown drainage pipe from Oak Summit Apts, possible drainage from indoor pool.
Action/BMP: Follow-up with the apartment management.

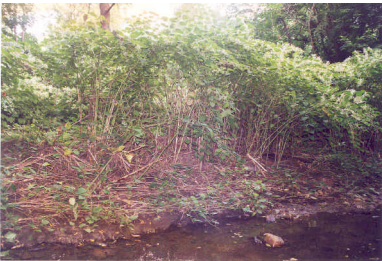
3. Spread of knotweed along left bank
Action/BMP: Develop eradication program for knotweed

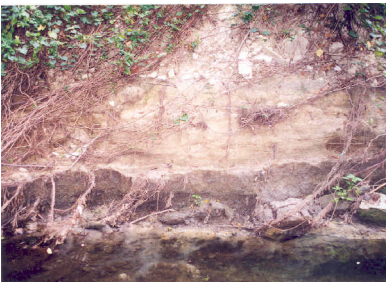
4. Vertical creek bank behind Oak Summit Apts., scouring of bank and undercutting
Action/BMP: Develop a plan for biotechnical streambank restoration

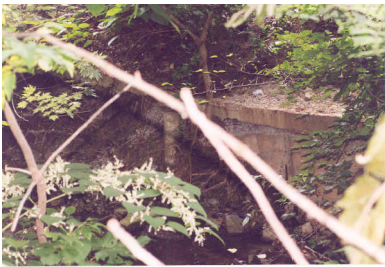
5. Broken concrete bulkhead
Action/BMP: Have the township engineer assess the problem and develop solution.

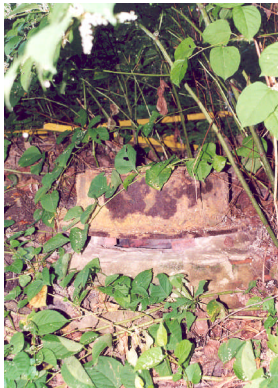
6. Broken/breached concrete collar of sanitary sewer
Action/BMP: Have the township engineer assess the problem and develop solution

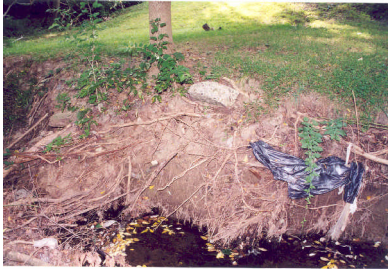
7. Erosion of streambank
Action/BMP: Develop a plan for biotechnical streambank restoration

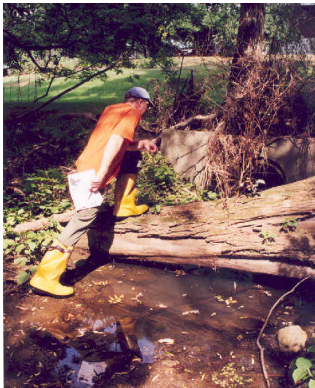
8. Discolored water & storm drain from General Patterson Drive
Action/BMP: Follow up on the source of the discharge.

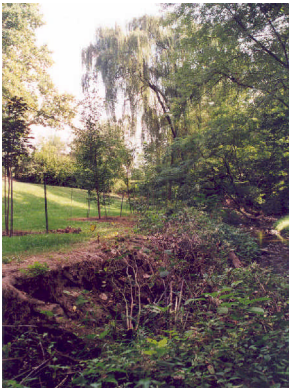
9. Stream bank erosion
Action/BMP : Develop a plan for biotechnical streambank restoration

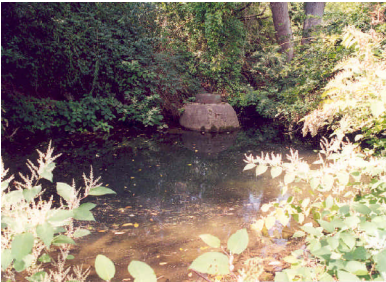
10. Discolored water in deep pool behind Kaname Gardens adjacent to Waverly Road
Action/BMP: Follow up with the nursery owner

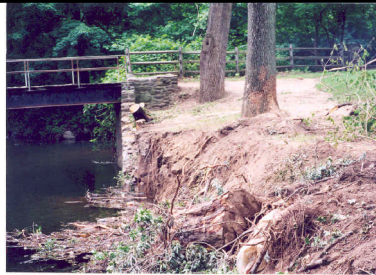
1. Pedestrian bridge at Jenkintown Creek shortly after Tropical Storm Allison (5/01). The surrounding area under the trees is routinely mowed to the bank.
Action/BMP : This area is currently undergoing biotechnical streambank restoration.

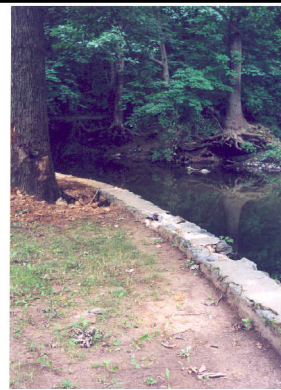
2. Typical mowed lawn up to the wall which prevents NPS pollution from being filtered by the riparian buffer and stabilizing the eroding channel bed
Action/BMP : Replant the understory of shrubs and herbaceous layer along walled areas of the Tookany Creek.

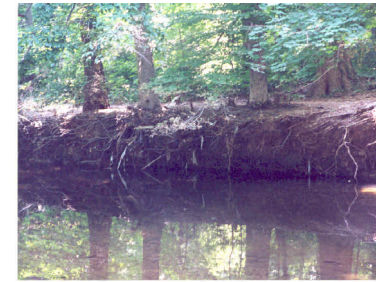
4. The steep wooded slopes of the west bank of the Tookany Creek along the Parkway are becoming undercut as a result of the upstream volumes of stormwater. The mature trees can hold the bank with their roots, but if the volume of water continues, the roots will be undermined and the trees will fall.
Action/BMP : Conduct a complete study of the hydrology of the Tookany Creek using the Rosgen model to develop a long-term plan for the restoration. Use biotechnical streambank restoration to fortify the roots and stabilize the banks.

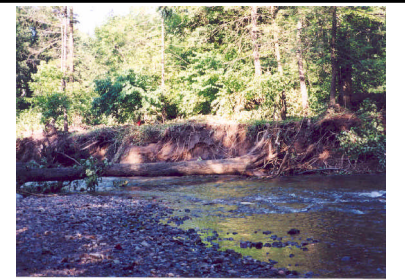
5. Newly eroded banks as a result of Tropical Storm Allison.
Action/BMP : This area is undergoing biotechnical streambank restoration. Continue to monitor for knotweed re-infestation.

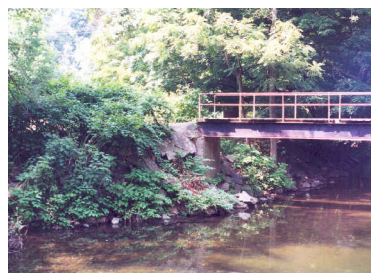
6. Japanese knotweed, an invasive, non-native plant, is the most common plant species along Tookany, replacing the native vegetation. It is very difficult to permanently get rid of.
Action/BMP : Develop an invasive species program to remove the knotweed and replace with native vegetation

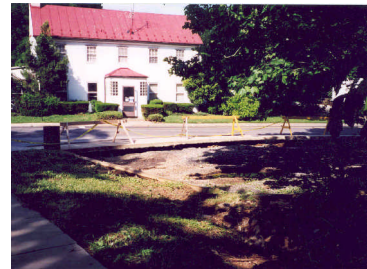
7. This intersection continually floods during storm events. This picture shows the severe damage to the road after Tropical Storm Allison in 2001.
Action/BMP : Conduct a complete study of the hydrology of the Tookany Creek using the Rosgen model to develop a long-term plan for the restoration.

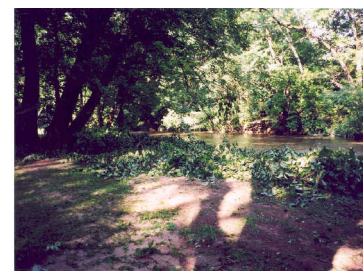
8 & 9. After Tropical Storm Allison, the severe flooding washed much debris on the banks and structures. The riparian buffer consists only of large trees with the ground layer mowed to the banks.
Action/BMP : Township should revise the mowing practices to less area and frequency. Plant the understory with native shrubs and herbaceous layer.

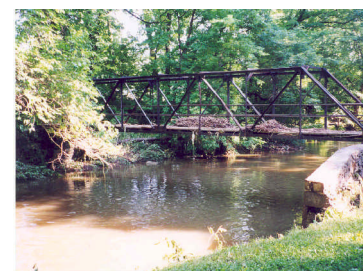
10. The area adjacent to the Tookany Parkway and the creek is mowed to the banks, preventing any filtering of the NPS pollution.
Action/BMP : The golf course and the township should revise the mowing practices to less area and frequency. Plant the understory with native shrubs and herbaceous layer to fortify the riparian buffer.

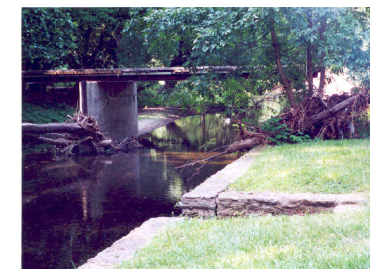
11. Melrose Golf Course maintains the grass to the creek bed, preventing any riparian filtration of NPS pollution.
Action/BMP : Encourage participation in the Audubon certification program for golf courses. Possibly reduce the greens directly next to the Tookany Creek and replant with native vegetation to filter NPS pollution and stabilize the banks.

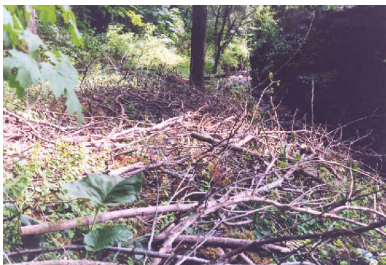
2. Baeder Creek piped under a garage and then under Abington Rd. /Ghost Rd. No water before pipe, on other side of road, water begins to flow. Three storm drains come together under road. For a long stretch, the stream is walled on one side (wood and stone). Other side 50% slope. Lots of brush thrown near stream bed from adjacent properties.

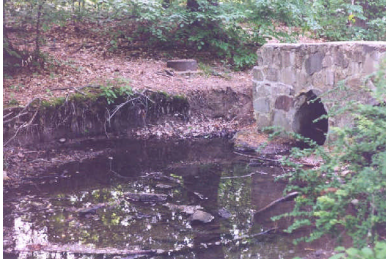
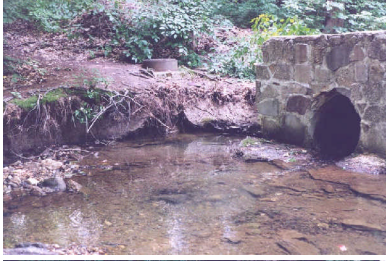
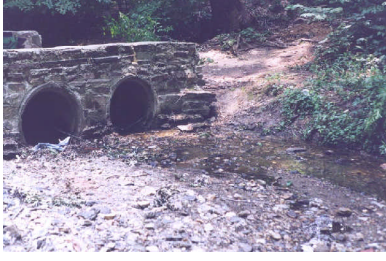
4. Baederwood Park near the creek with foot bridge. Stream widens to 15ft. Small wetland area as indicated by obligate plant species of skunk cabbage. Water clear. Slope 20% on one side, other side wetlands then gradual slope. Under cutting around foot bridge.

Action/BMP : Employ biotechnical streambank techniques to restore bank. After bridge, stream widens considerably in a spot. Bank really cut on side of playground. Action/BMP : Employ biotechnical streambank techniques to restore and stabilize bank.

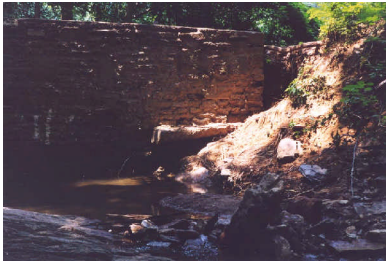
5. Attractive stone wall across the creek, 20 ft high 3ft. gap cut into it - possibly used to slow down water flow. Several mature beech trees, maples, tulip, and oak. A great deal of in-channel erosion.

Action/BMP : Employ Biotechnical streambank techniques to restore bank to repair channel erosion and bring the banks to more natural 3:1 slope and replant with native vegetation

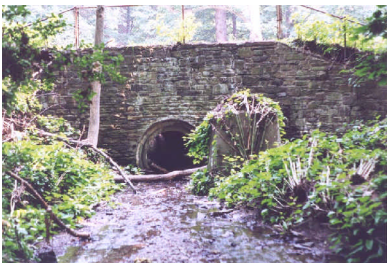
6. Creek flows under Highland Ave. Sewer line in creek bed, undercut. Lots of Knotweed.

Action/BMP : Have Abington Township engineer evaluate sewer line stability and consider biotechnical streambank techniques to repair bank and remove the knotweed with native plants simultaneously.

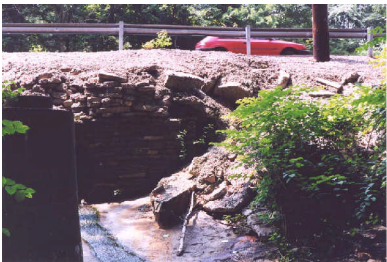
4.5 foot diameter pipe carrying water under the road. Erosion, breakage of road falling down into stream.

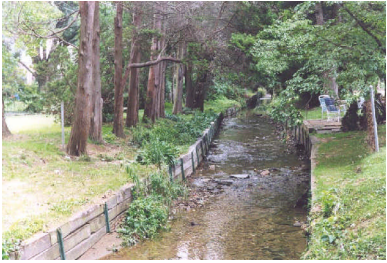
11. After flowing under Baeder Road, the stream is walled in on both sides. Walls vary in height from 6 to 12 feet in spots. The vertical wall is 6x6 lumber most of the way. Along part of the creek, the wall is cement.

Action/BMP : Consider removing the walls and employ biotechnical streambank techniques to restore riparian buffer and its essential functions, and allow the bank to become a more natural 3:1 slope and replant with native vegetation.

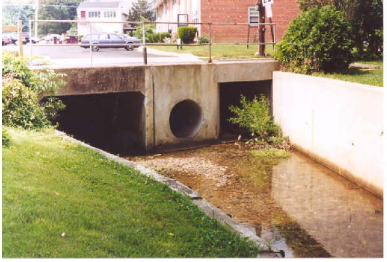
12. The stream travels under the Madison Apartments parking lot and then under Jenkintown Rd.

Action/BMP : Stop mowing to the creek banks; Employ Biotechnical streambank techniques to restore bank to a more natural 3:1 slope and replant with native vegetation.

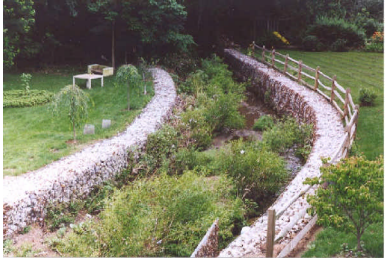
13. On the other side of Jenkintown Road, the creek reappears in a residential neighborhood. Gabion baskets make up the vertical walls on both sides. Native veg. such as willows and viburnum growing in stream bed.

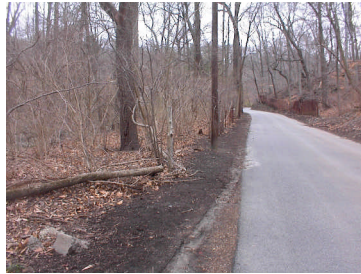
8. For the next half mile from Washington Lane to the Rock Lane bridge, the stream flows through a wooded valley with the lightly traveled Rock Lane close on its southern bank.
Action/BMP : No action necessary; continue to maintain the land uses surrounding this area.

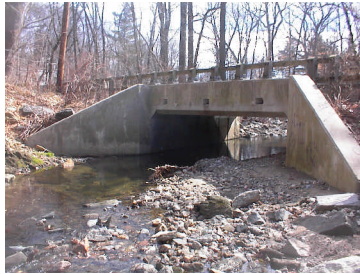
9. Small fish (up to 6") frequent the pool under the Rock Lane Bridge. The channel is more stable and naturalized due to the vegetated stream banks.
Action/BMP : No action necessary; continue to maintain the land uses surrounding this area.

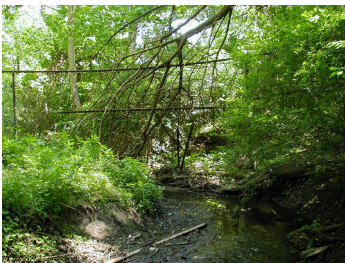
A4. In Alverthorpe Park, there is a break in the fence with a well-worn path into the park. The creek flows under the park bicycle trail and empties into Alverthorpe pond.
Action/BMP : None.

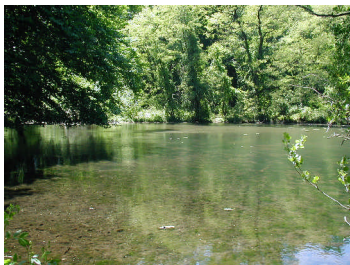
A5. The pond area has a geese problem that is feeding the algae, as evidenced by the large amounts of droppings, which cause NPS pollution in the pond. A chip and putt golf course is located close to the pond which may be contributing to the nutrient loading in the pond.
Action/BMP : Investigate and discourage the habitat that is inviting the geese to the pond area. Alter land management practices in the park to restore pond shoreline including the BMP's for the chip and putt course.

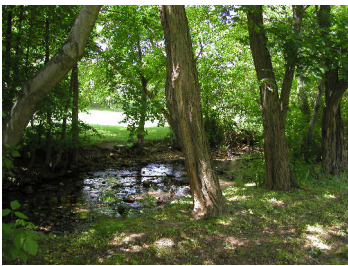
A7. As the creek exits from the culvert under Cadwalader Rd. (east side) the creek widens to about 15 feet and turns to the left. There is some evidence of erosion on the south bank at the turn. This point corresponds to the northwest corner of Ethel M. Jordan Memorial Park (behind McKinley Firehouse). The park lawn in the background is mowed almost to the creek banks.
Action/BMP : Leave more of a riparian buffer on the park side of the creek by mowing less.

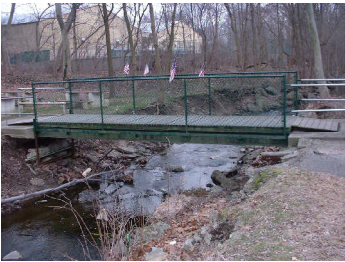
C3. The VFW picnic grove is in jeopardy of being lost due to eroding stream banks. It appears that the stream is increasing its channel size to accommodate the larger volume of flows from upstream.
Action/BMP : Mow less of the area for more on-site infiltration. Work with upstream landowners to also use on-site infiltration BMPs.
