OFMI 22-01.0, Plate 2  
Water Depth of  
Spillway Area  
**Pymatuning Reservoir**  
Pymatuning State Park,  
Crawford County, Pennsylvania  
and Ashtabula County, Ohio  
[www.dcnr.pa.gov/StateParks](http://www.dcnr.pa.gov/StateParks)

## Pymatuning Reservoir

Pymatuning State Park,  
Crawford County, Pennsylvania  
and Ashtabula County, Ohio

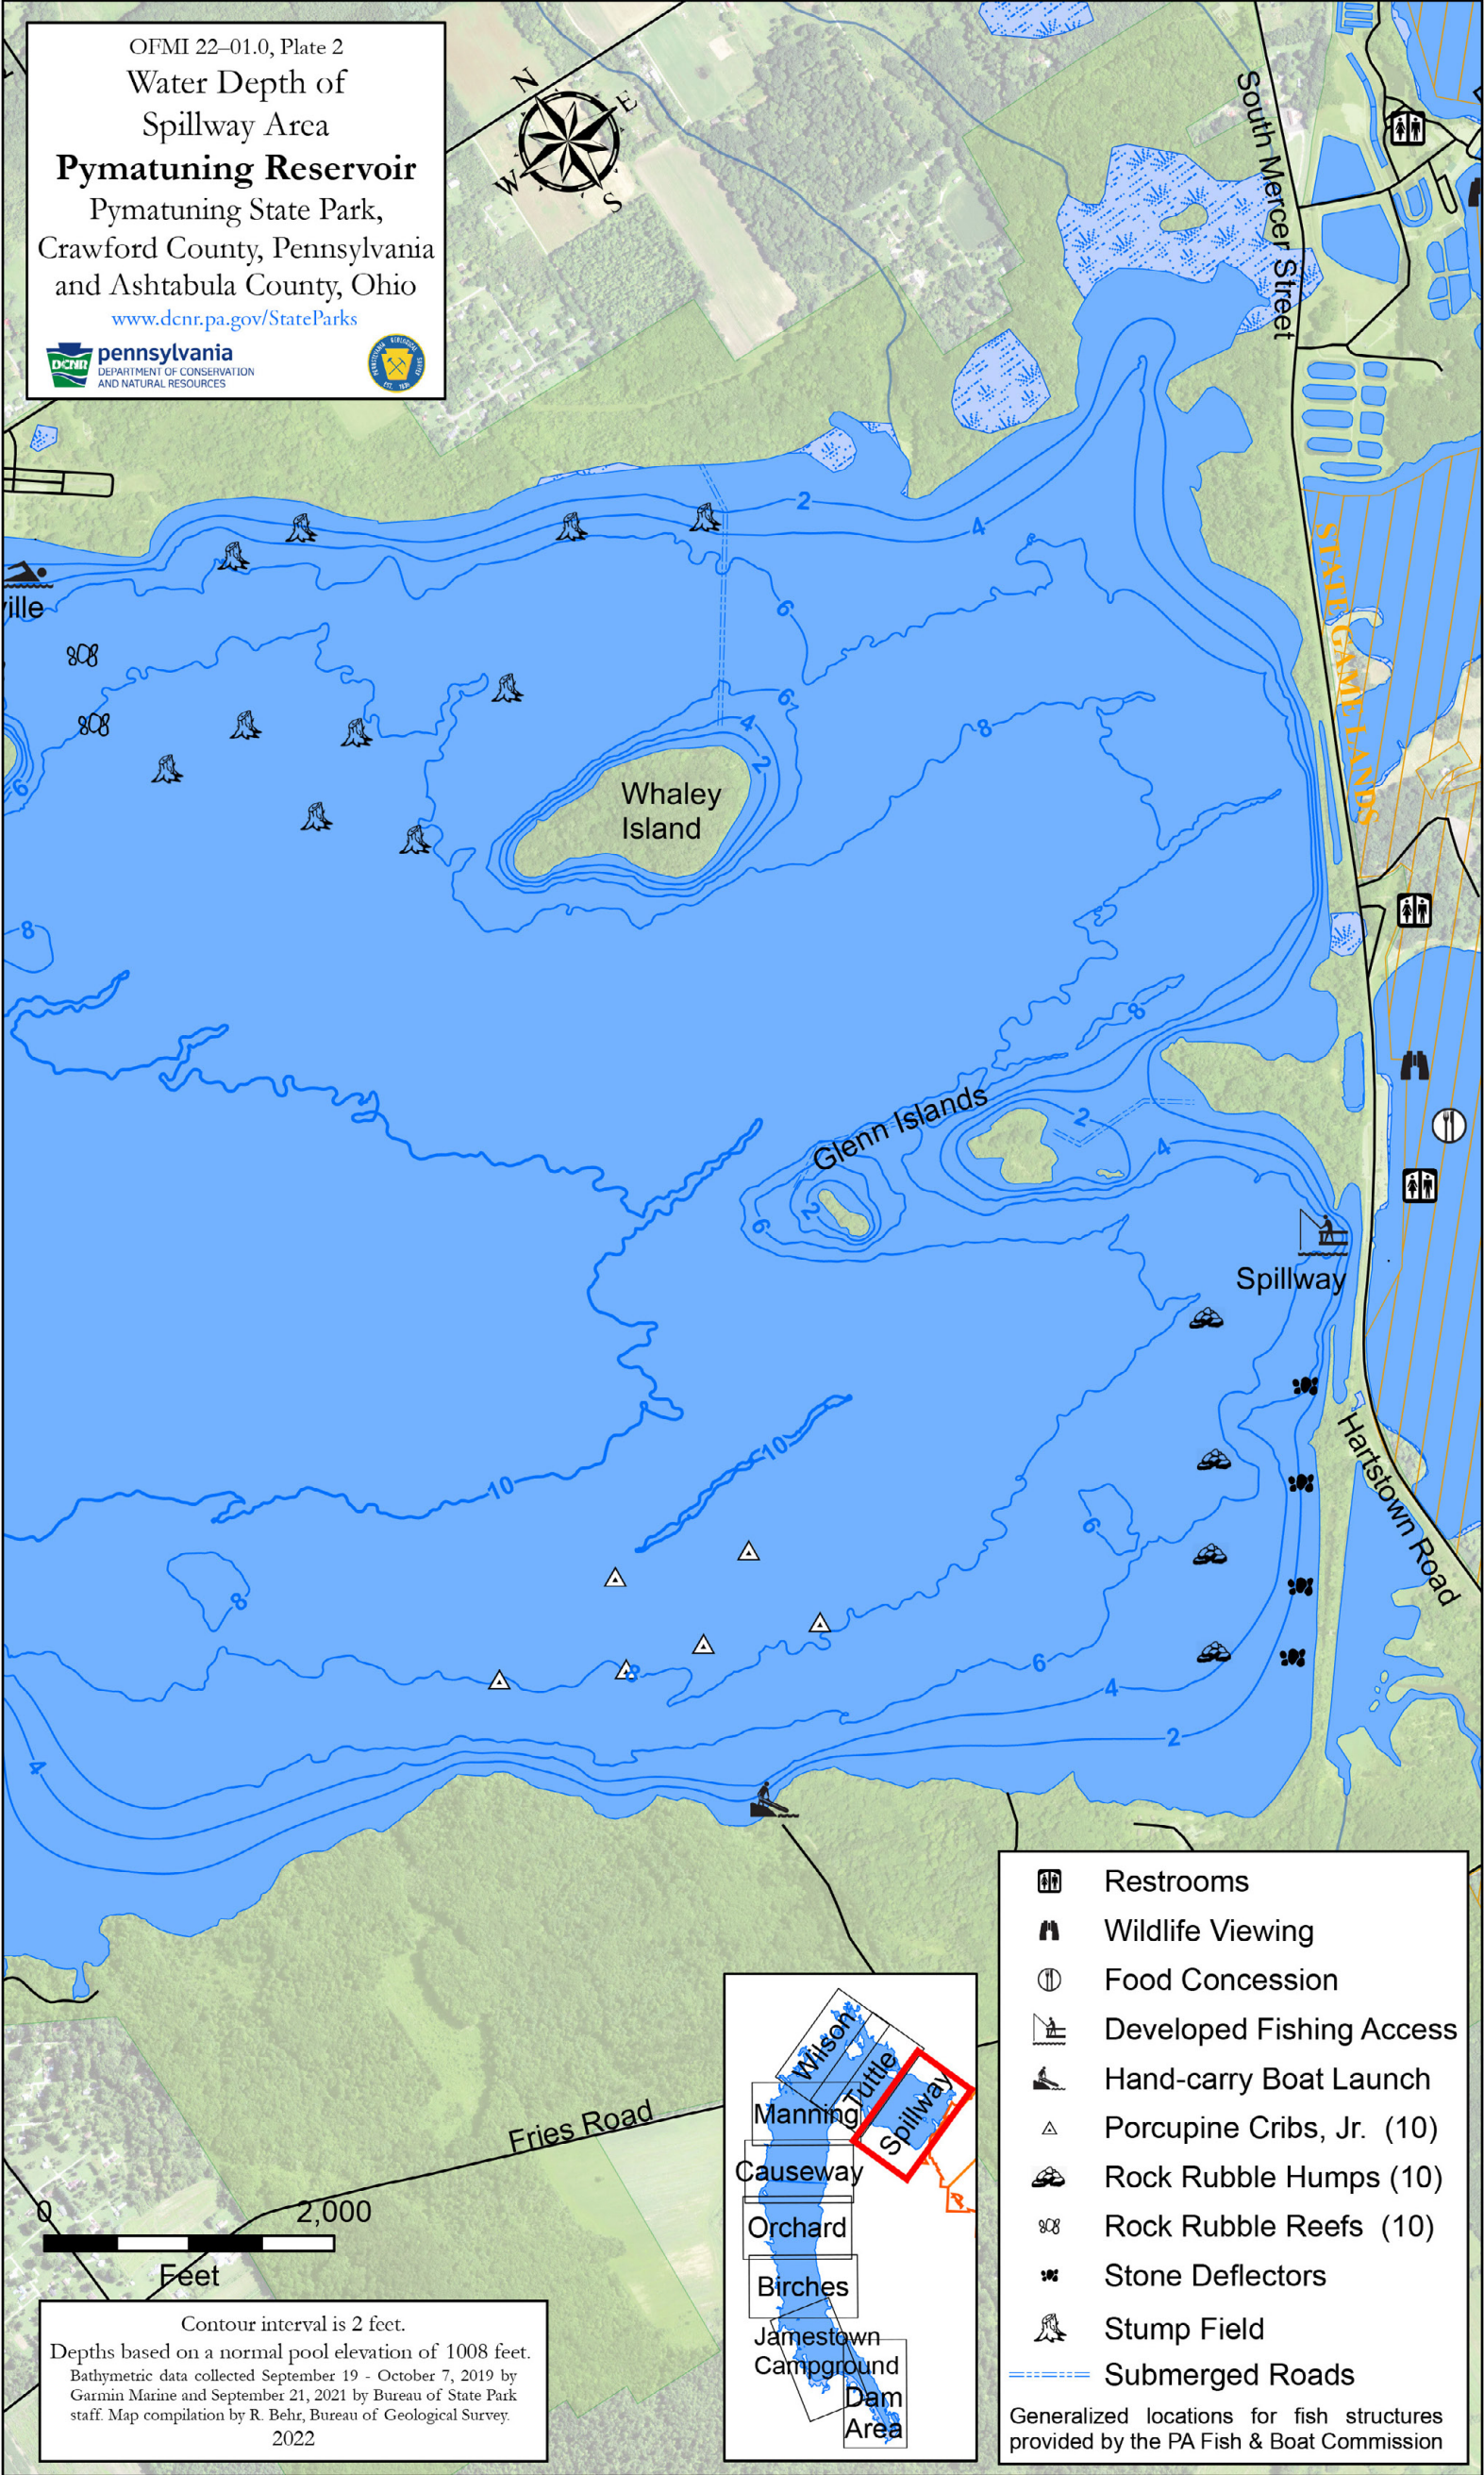
Contour interval is 2 feet.  
Depths based on a normal pool elevation of 1008 feet.  
Bathymetric data collected September 19 - October 7, 2019 by  
Garmin Marine and September 21, 2021 by Bureau of State Park  
staff. Map compilation by R. Behr, Bureau of Geological Survey.  
2022

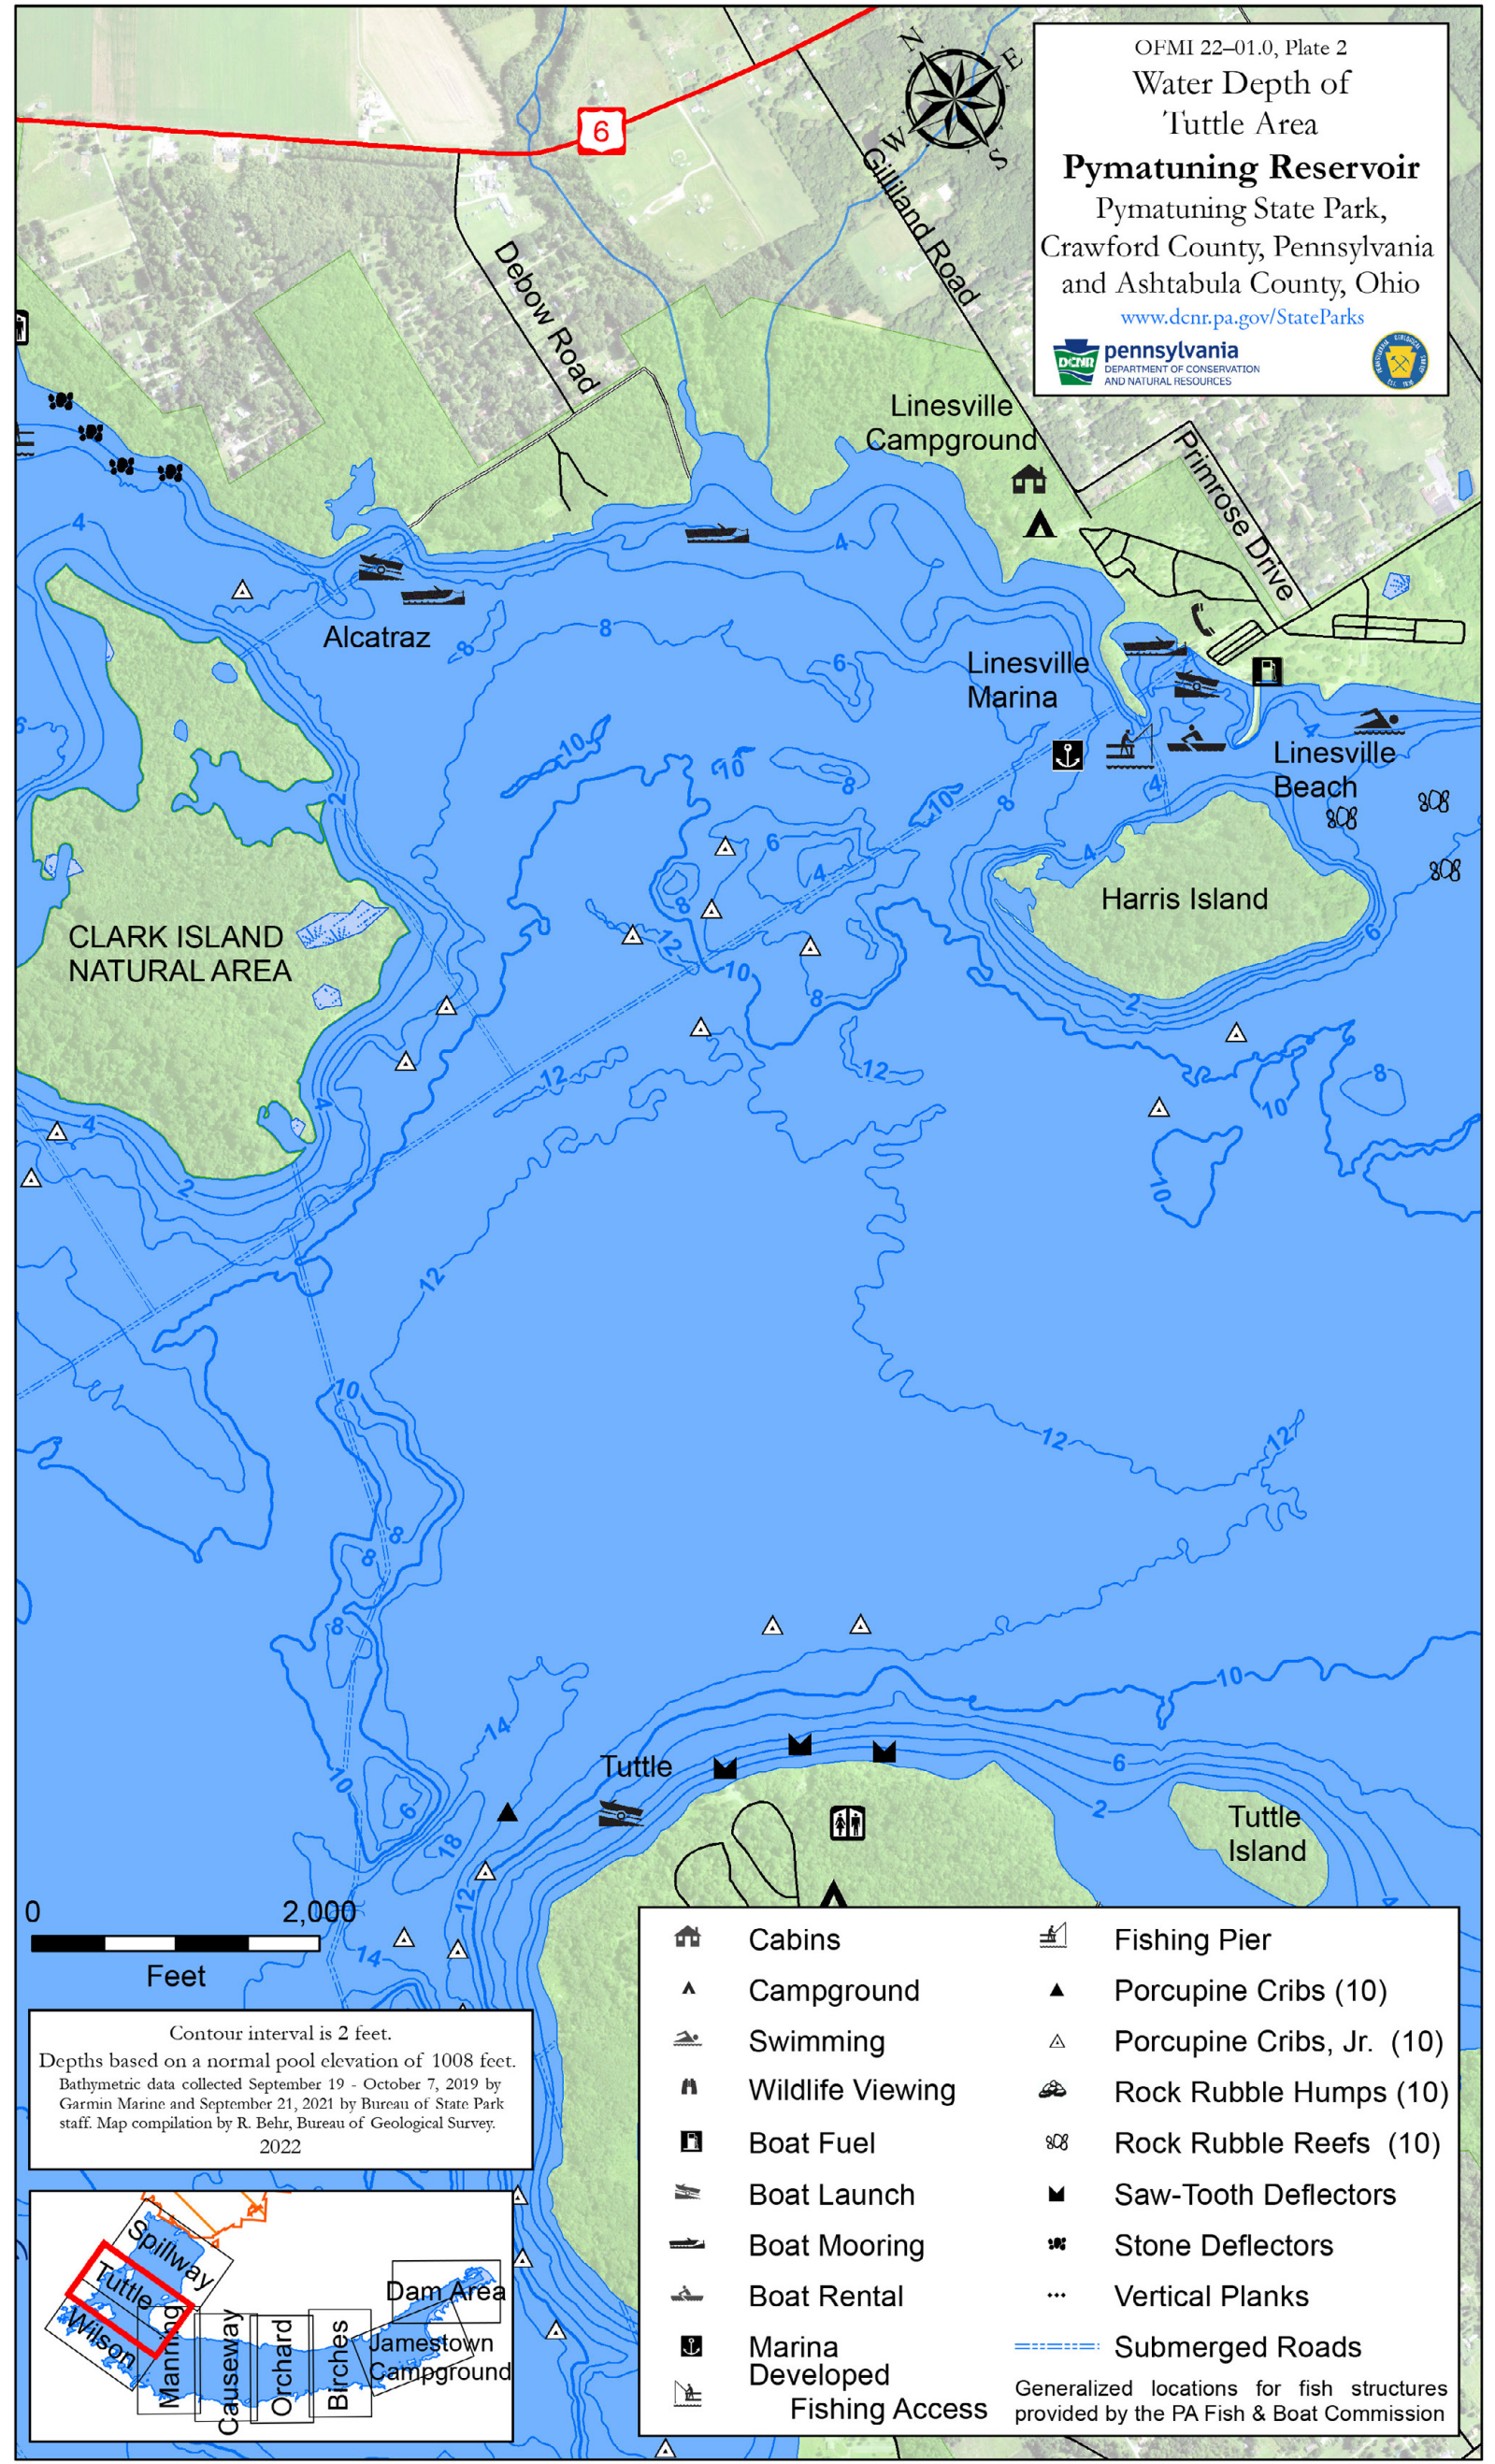
# Water Depth of 'Tuttle Area

Contour interval is 2 feet.

Depths based on a normal pool elevation of 1008 feet.  
Bathymetric data collected September 19 - October 7, 2019 by  
Garmin Marine and September 21, 2021 by Bureau of State Park  
staff. Map compilation by R. Behr, Bureau of Geological Survey.  
2022

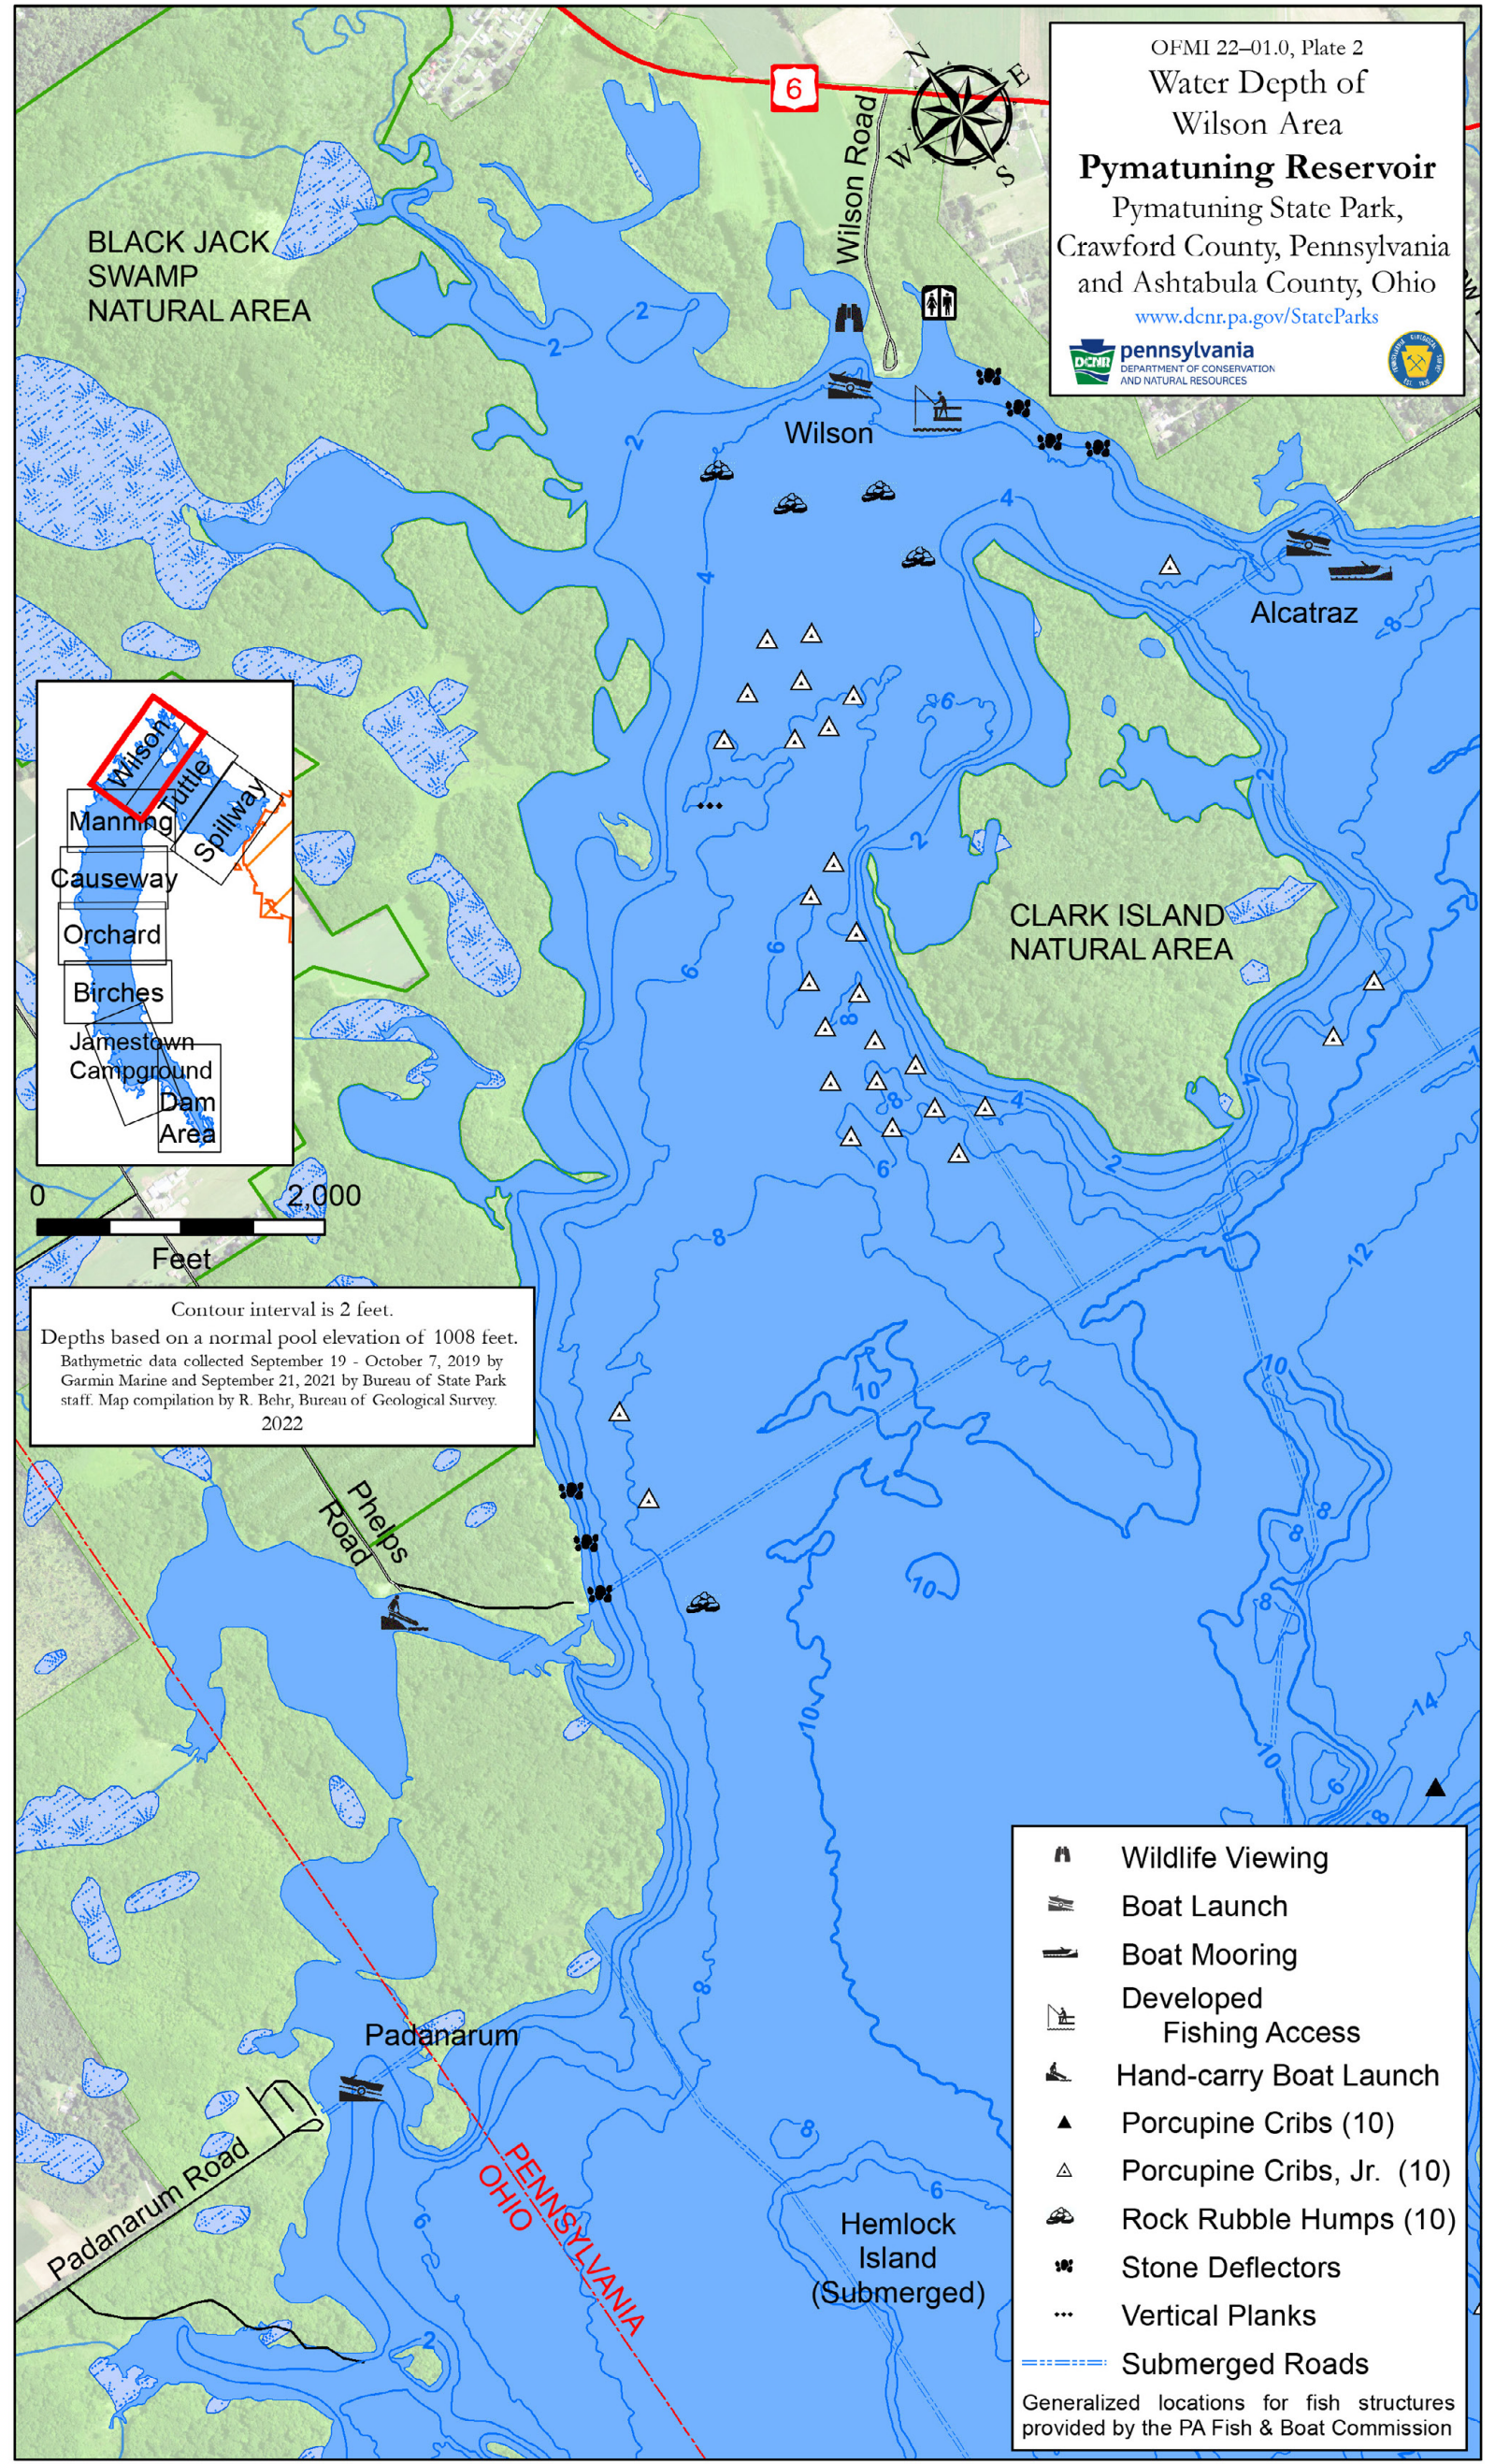
# Water Depth of Wilson Area

Contour interval is 2 feet.  
Depths based on a normal pool elevation of 1008 feet.  
Bathymetric data collected September 19 - October 7, 2019 by  
Garmin Marine and September 21, 2021 by Bureau of State Park  
staff. Map compilation by R. Behr, Bureau of Geological Survey.  
2022

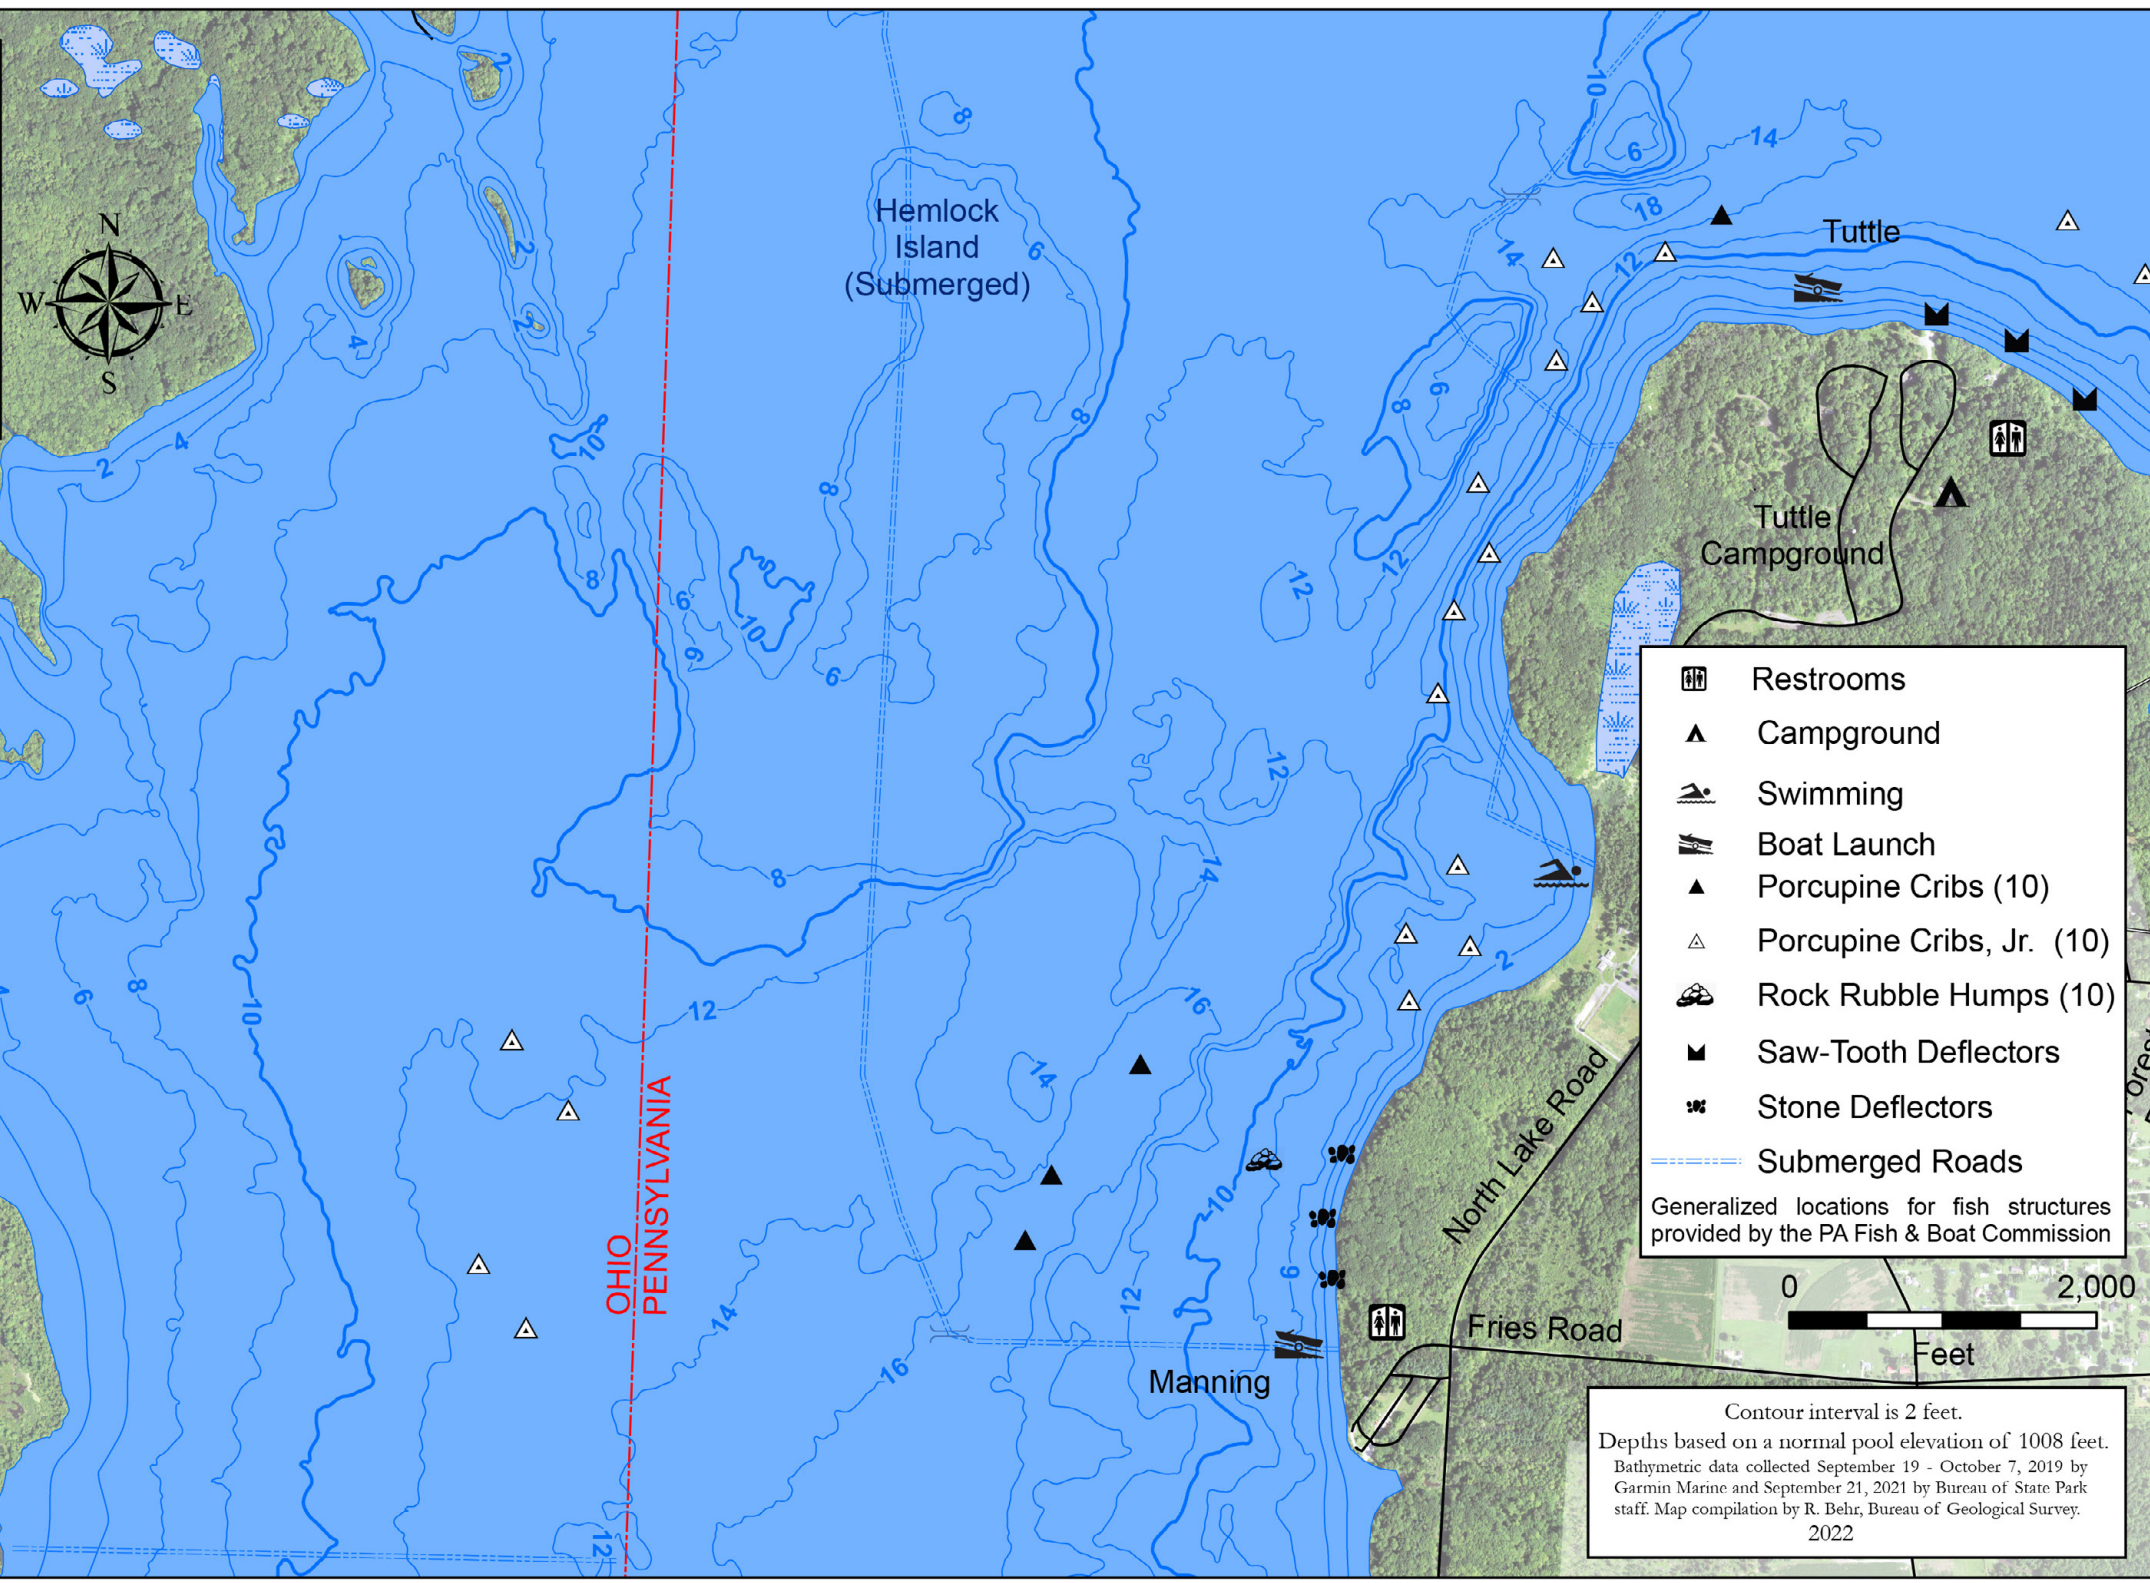
OFMI 22-01.0, Plate 2  
Water Depth of  
Manning Area  
**Pymatuning Reservoir**  
Pymatuning State Park,  
Crawford County, Pennsylvania  
and Ashtabula County, Ohio  
[www.dcnr.pa.gov/StateParks](http://www.dcnr.pa.gov/StateParks)

The inset map shows the entire Pymatuning Reservoir system, including areas like Wilson, Tuttle, Spillway, Causeway, Orchard, Birches, Jamestown Campground, and the Dam Area. The Manning area is highlighted with a red rectangle.

Contour interval is 2 feet.  
Depths based on a normal pool elevation of 1008 feet.  
Bathymetric data collected September 19 - October 7, 2019 by  
Garmin Marine and September 21, 2021 by Bureau of State Park  
staff. Map compilation by R. Behr, Bureau of Geological Survey.  
2022

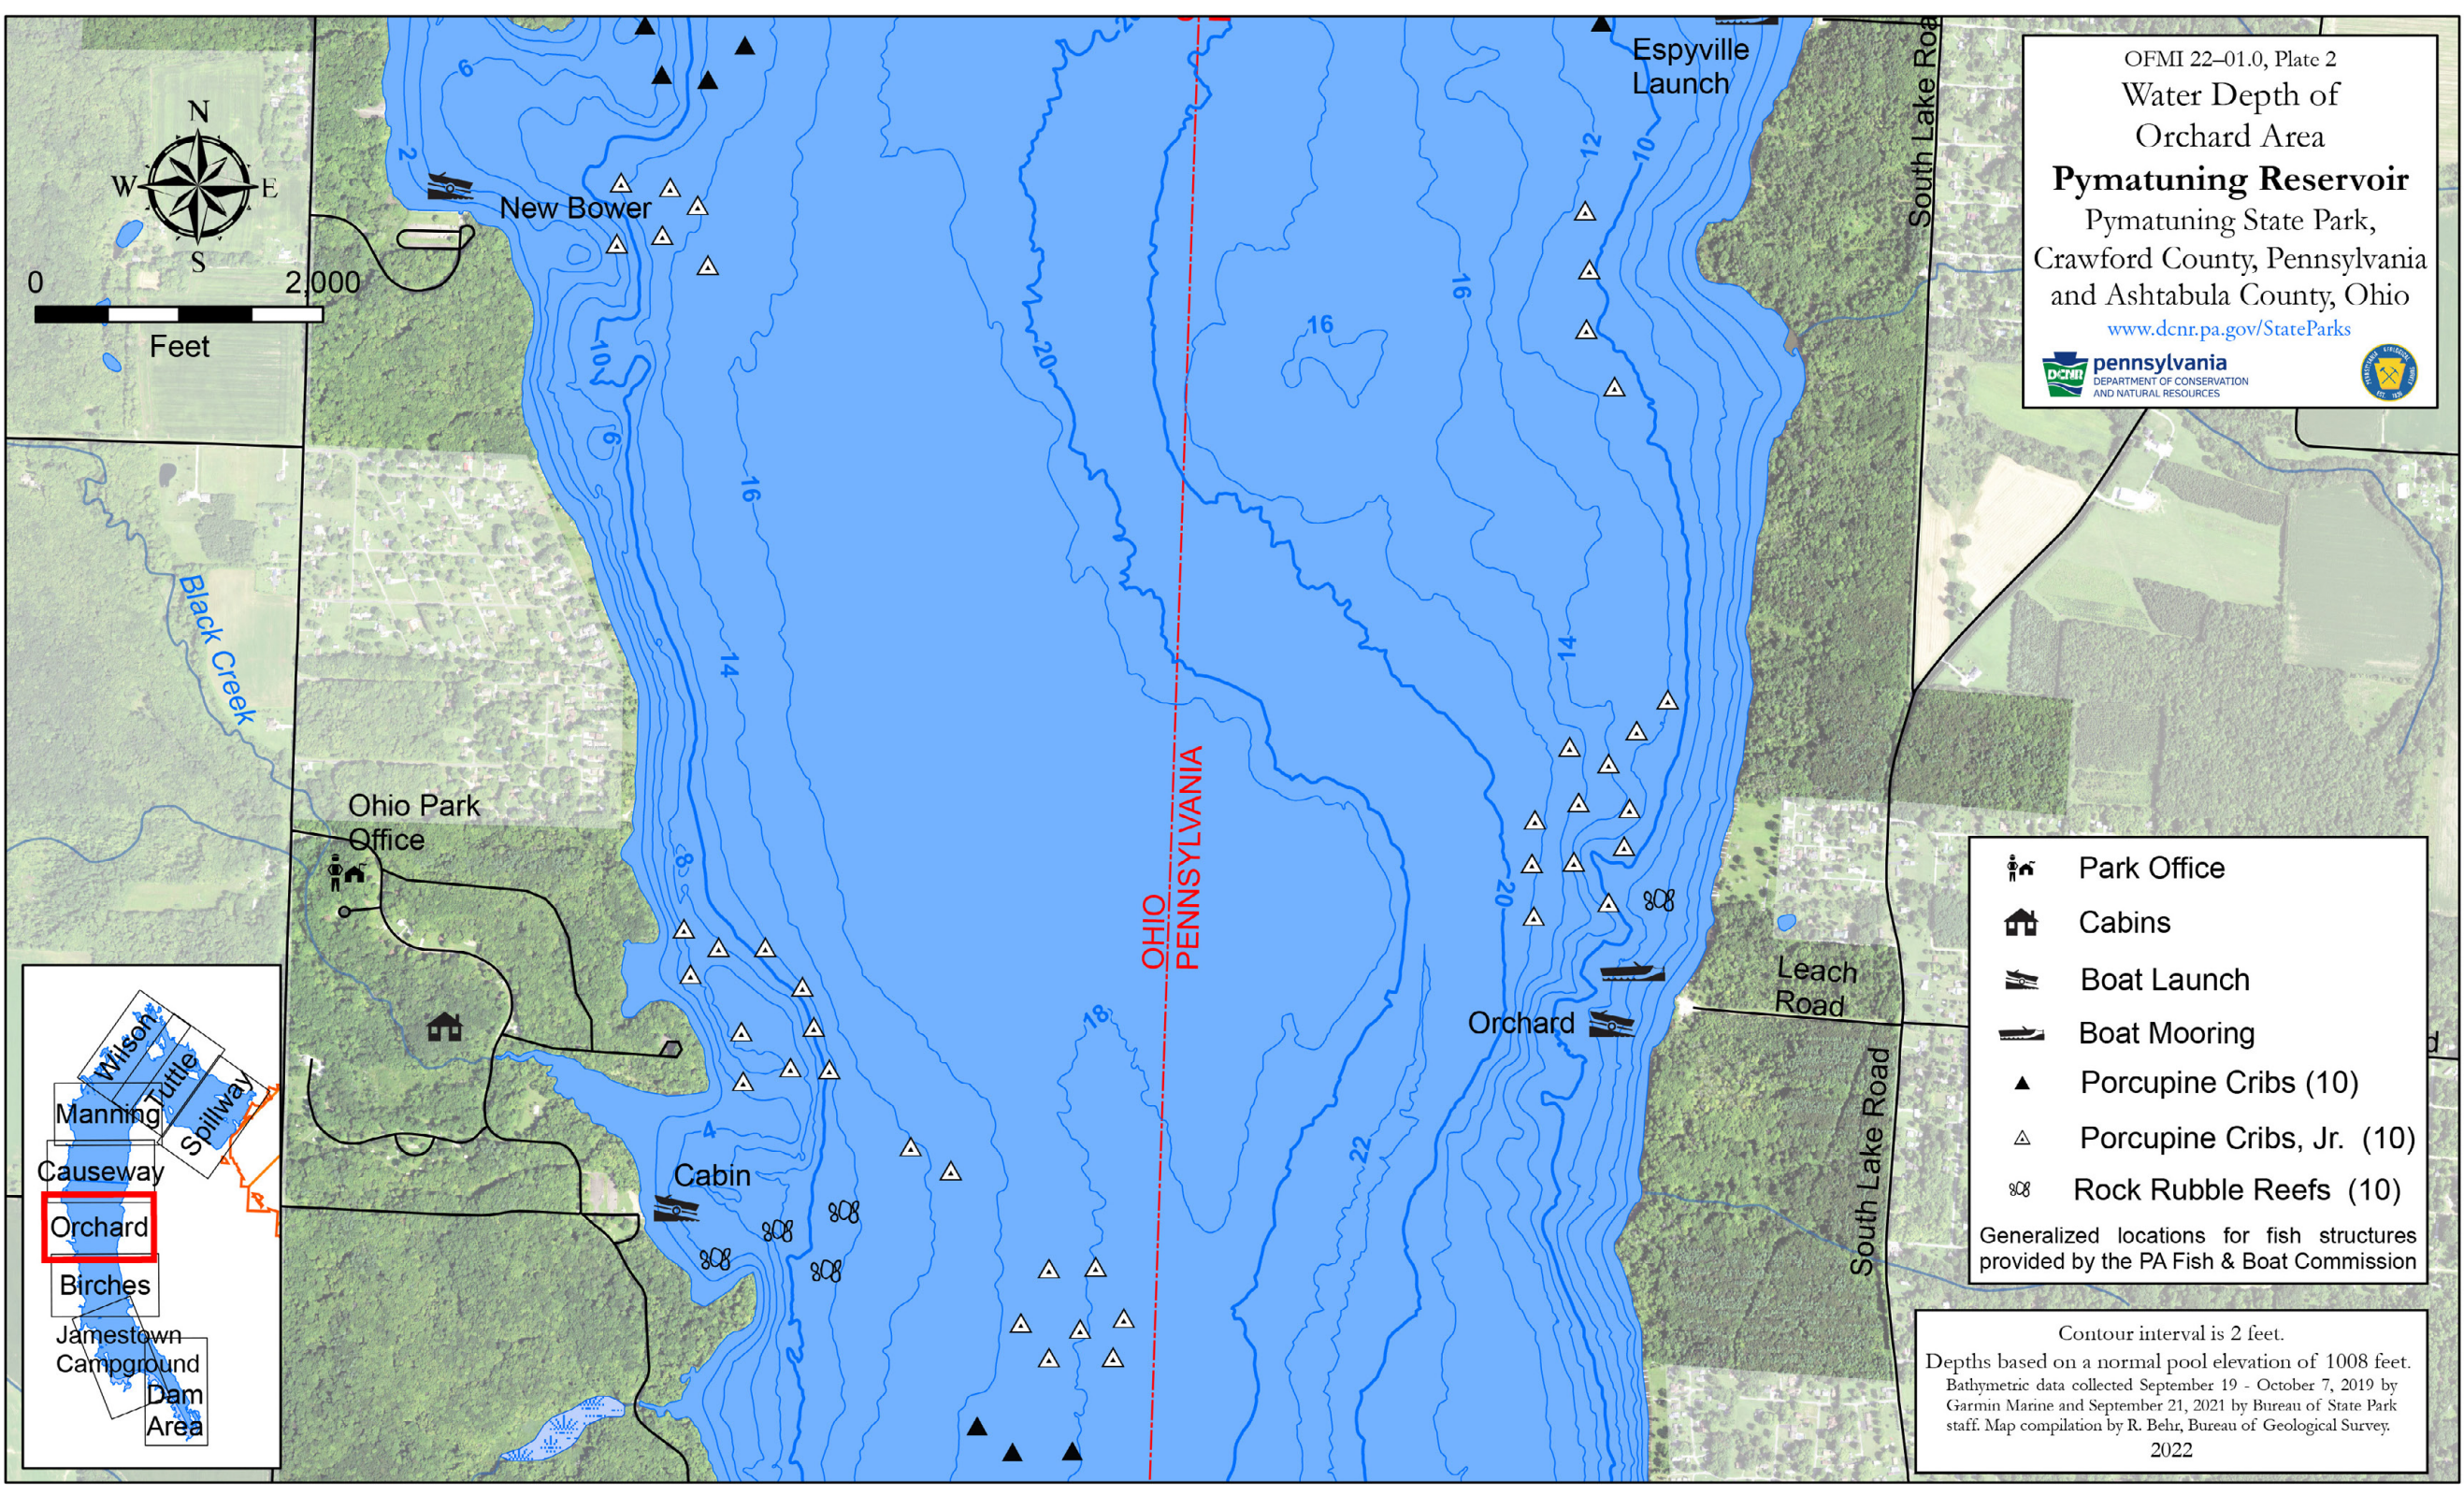
OFMI 22-01.0, Plate 2  
Water Depth of  
Orchard Area  
**Pymatuning Reservoir**  
Pymatuning State Park,  
Crawford County, Pennsylvania  
and Ashtabula County, Ohio  
[www.dcnr.pa.gov/StateParks](http://www.dcnr.pa.gov/StateParks)

Contour interval is 2 feet.  
Depths based on a normal pool elevation of 1008 feet.  
Bathymetric data collected September 19 - October 7, 2019 by  
Garmin Marine and September 21, 2021 by Bureau of State Park  
staff. Map compilation by R. Behr, Bureau of Geological Survey.  
2022

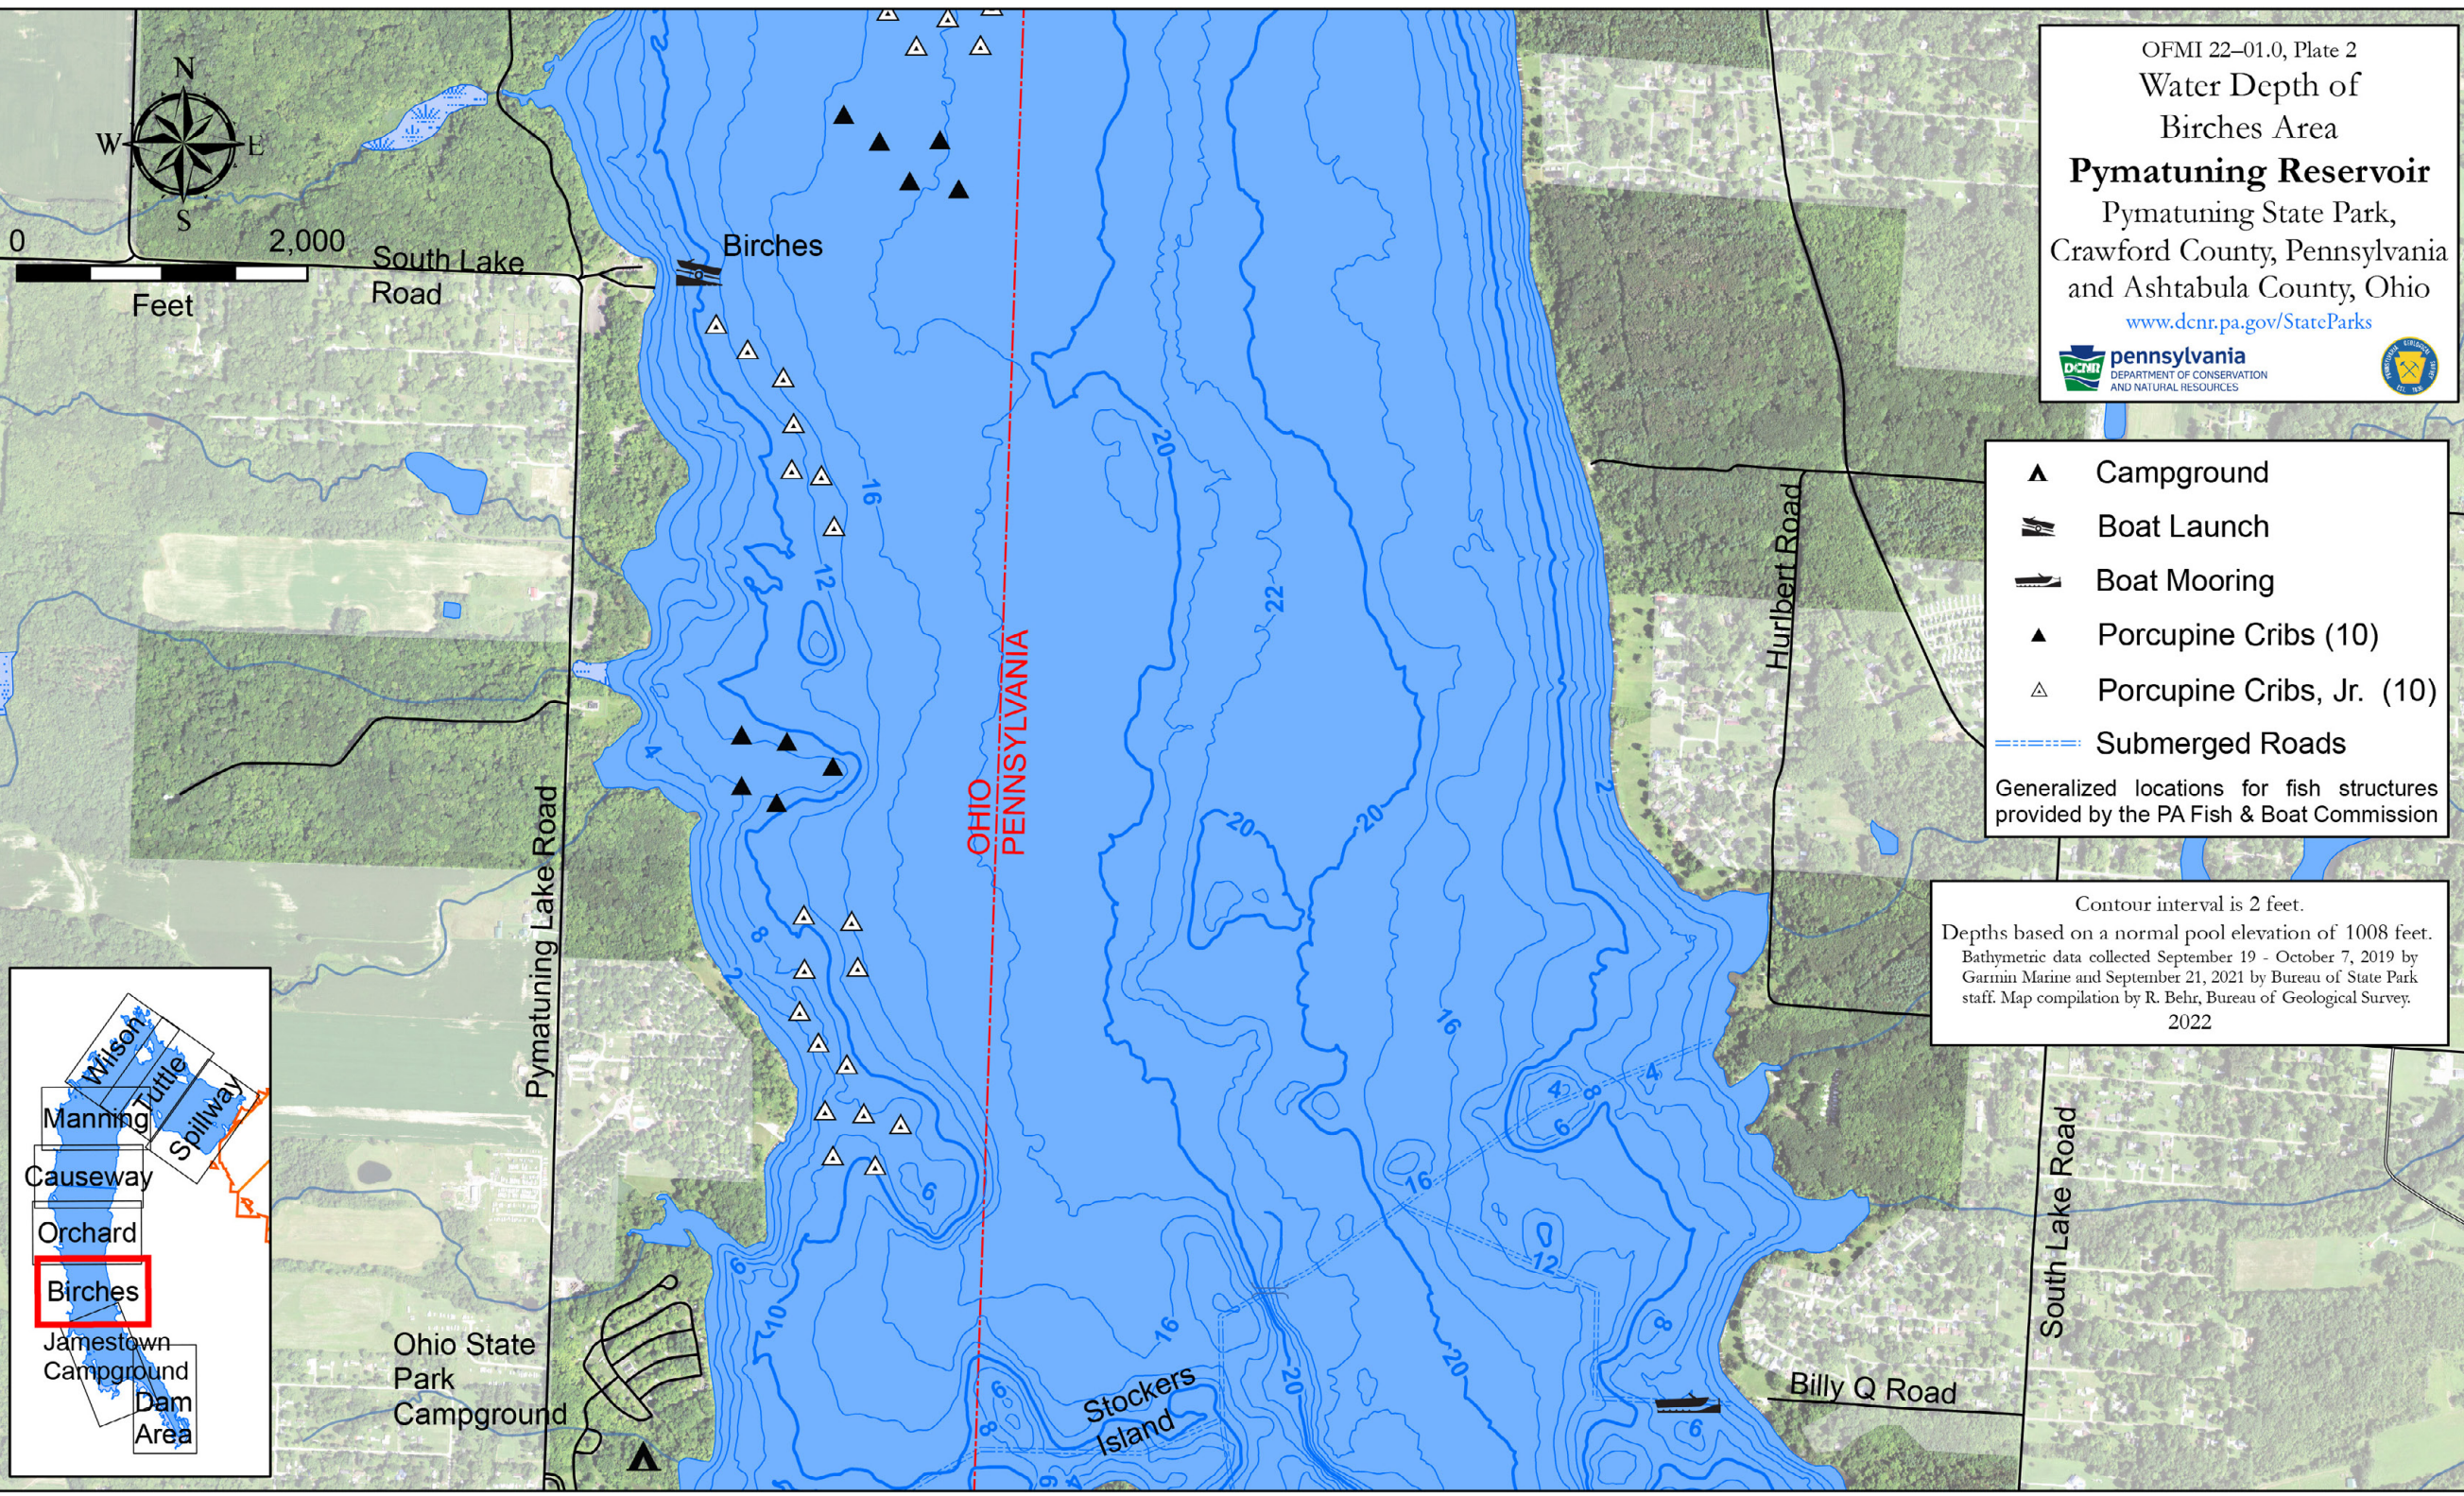
Birches Area

Contour interval is 2 feet.

Depths based on a normal pool elevation of 1008 feet.  
Bathymetric data collected September 19 - October 7, 2019 by  
Garmin Marine and September 21, 2021 by Bureau of State Park  
staff. Map compilation by R. Behr, Bureau of Geological Survey.  
2022
