OFMI 22-01.0, Plate 2  
Water Depth of  
Spillway Area  
**Pymatuning Reservoir**  
Pymatuning State Park,  
Crawford County, Pennsylvania  
and Ashtabula County, Ohio  
[www.dcnr.pa.gov/StateParks](http://www.dcnr.pa.gov/StateParks)

## Pymatuning Reservoir

Pymatuning State Park,  
Crawford County, Pennsylvania  
and Ashtabula County, Ohio

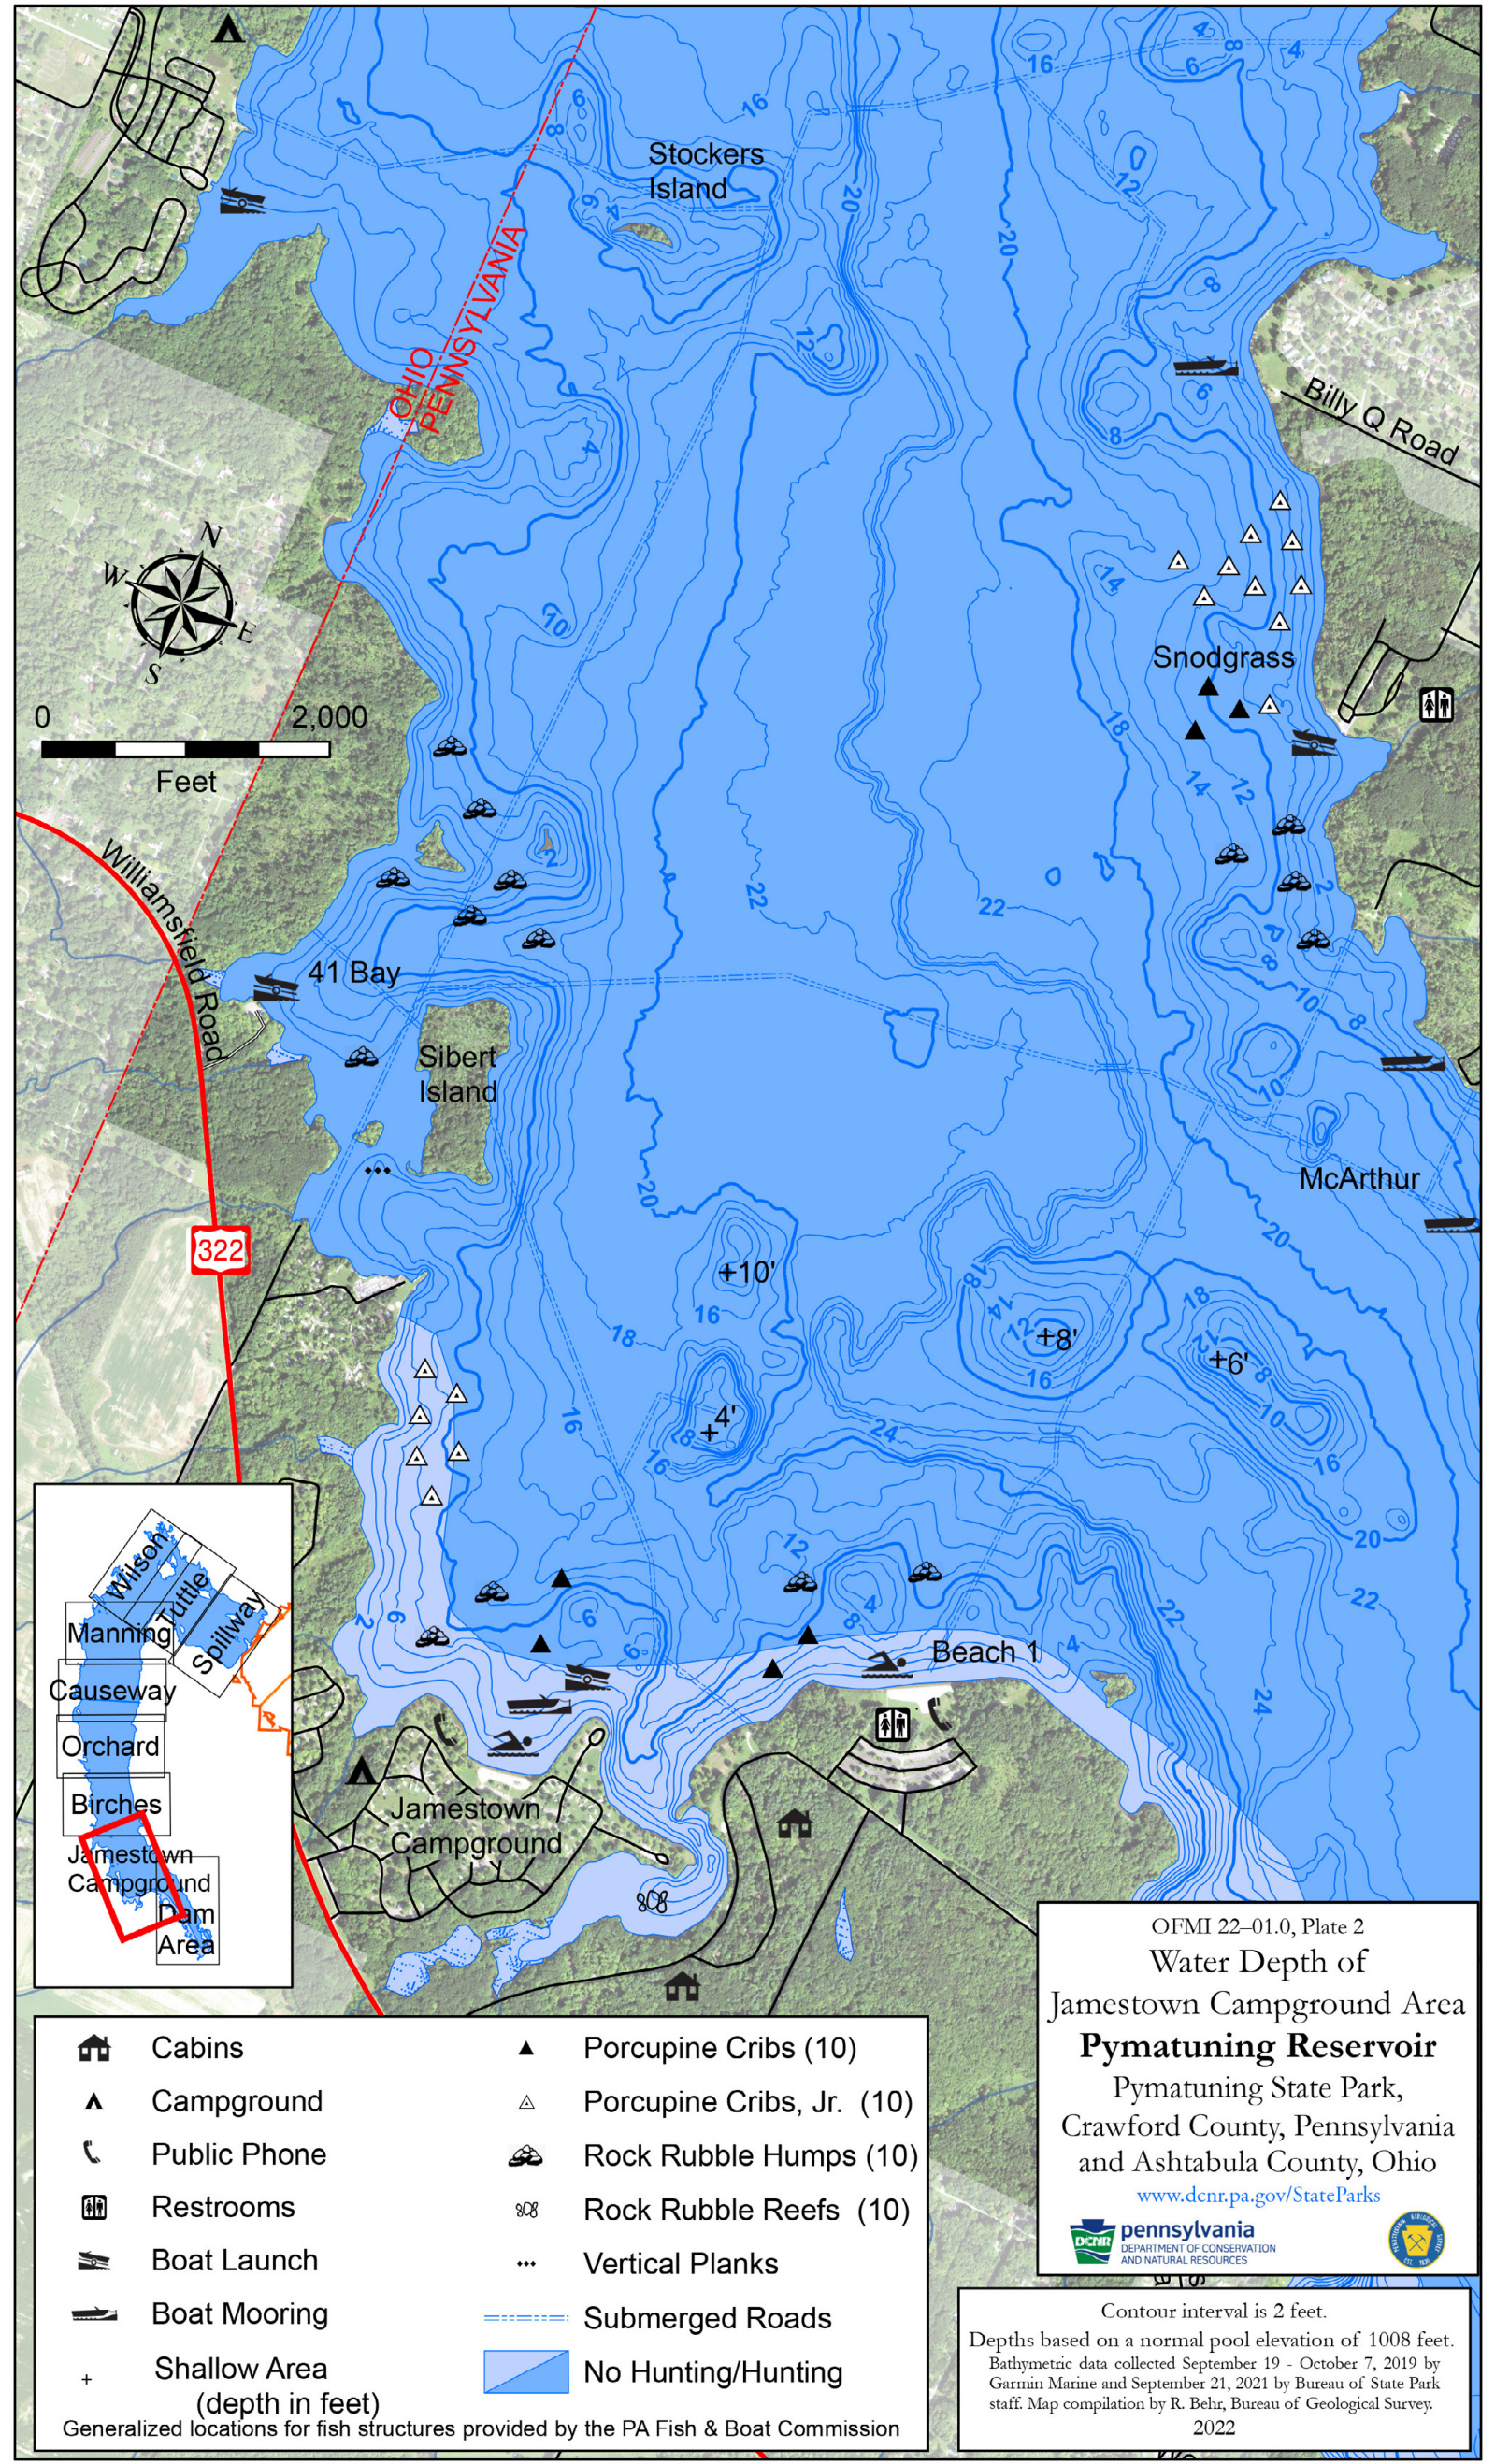
OFMI 22-01.0, Plate 2  
Water Depth of  
Jamestown Campground Area  
**Pymatuning Reservoir**

Contour interval is 2 feet.

Depths based on a normal pool elevation of 1008 feet.  
Bathymetric data collected September 19 - October 7, 2019 by  
Garmin Marine and September 21, 2021 by Bureau of State Park  
staff. Map compilation by R. Behr, Bureau of Geological Survey.  
2022

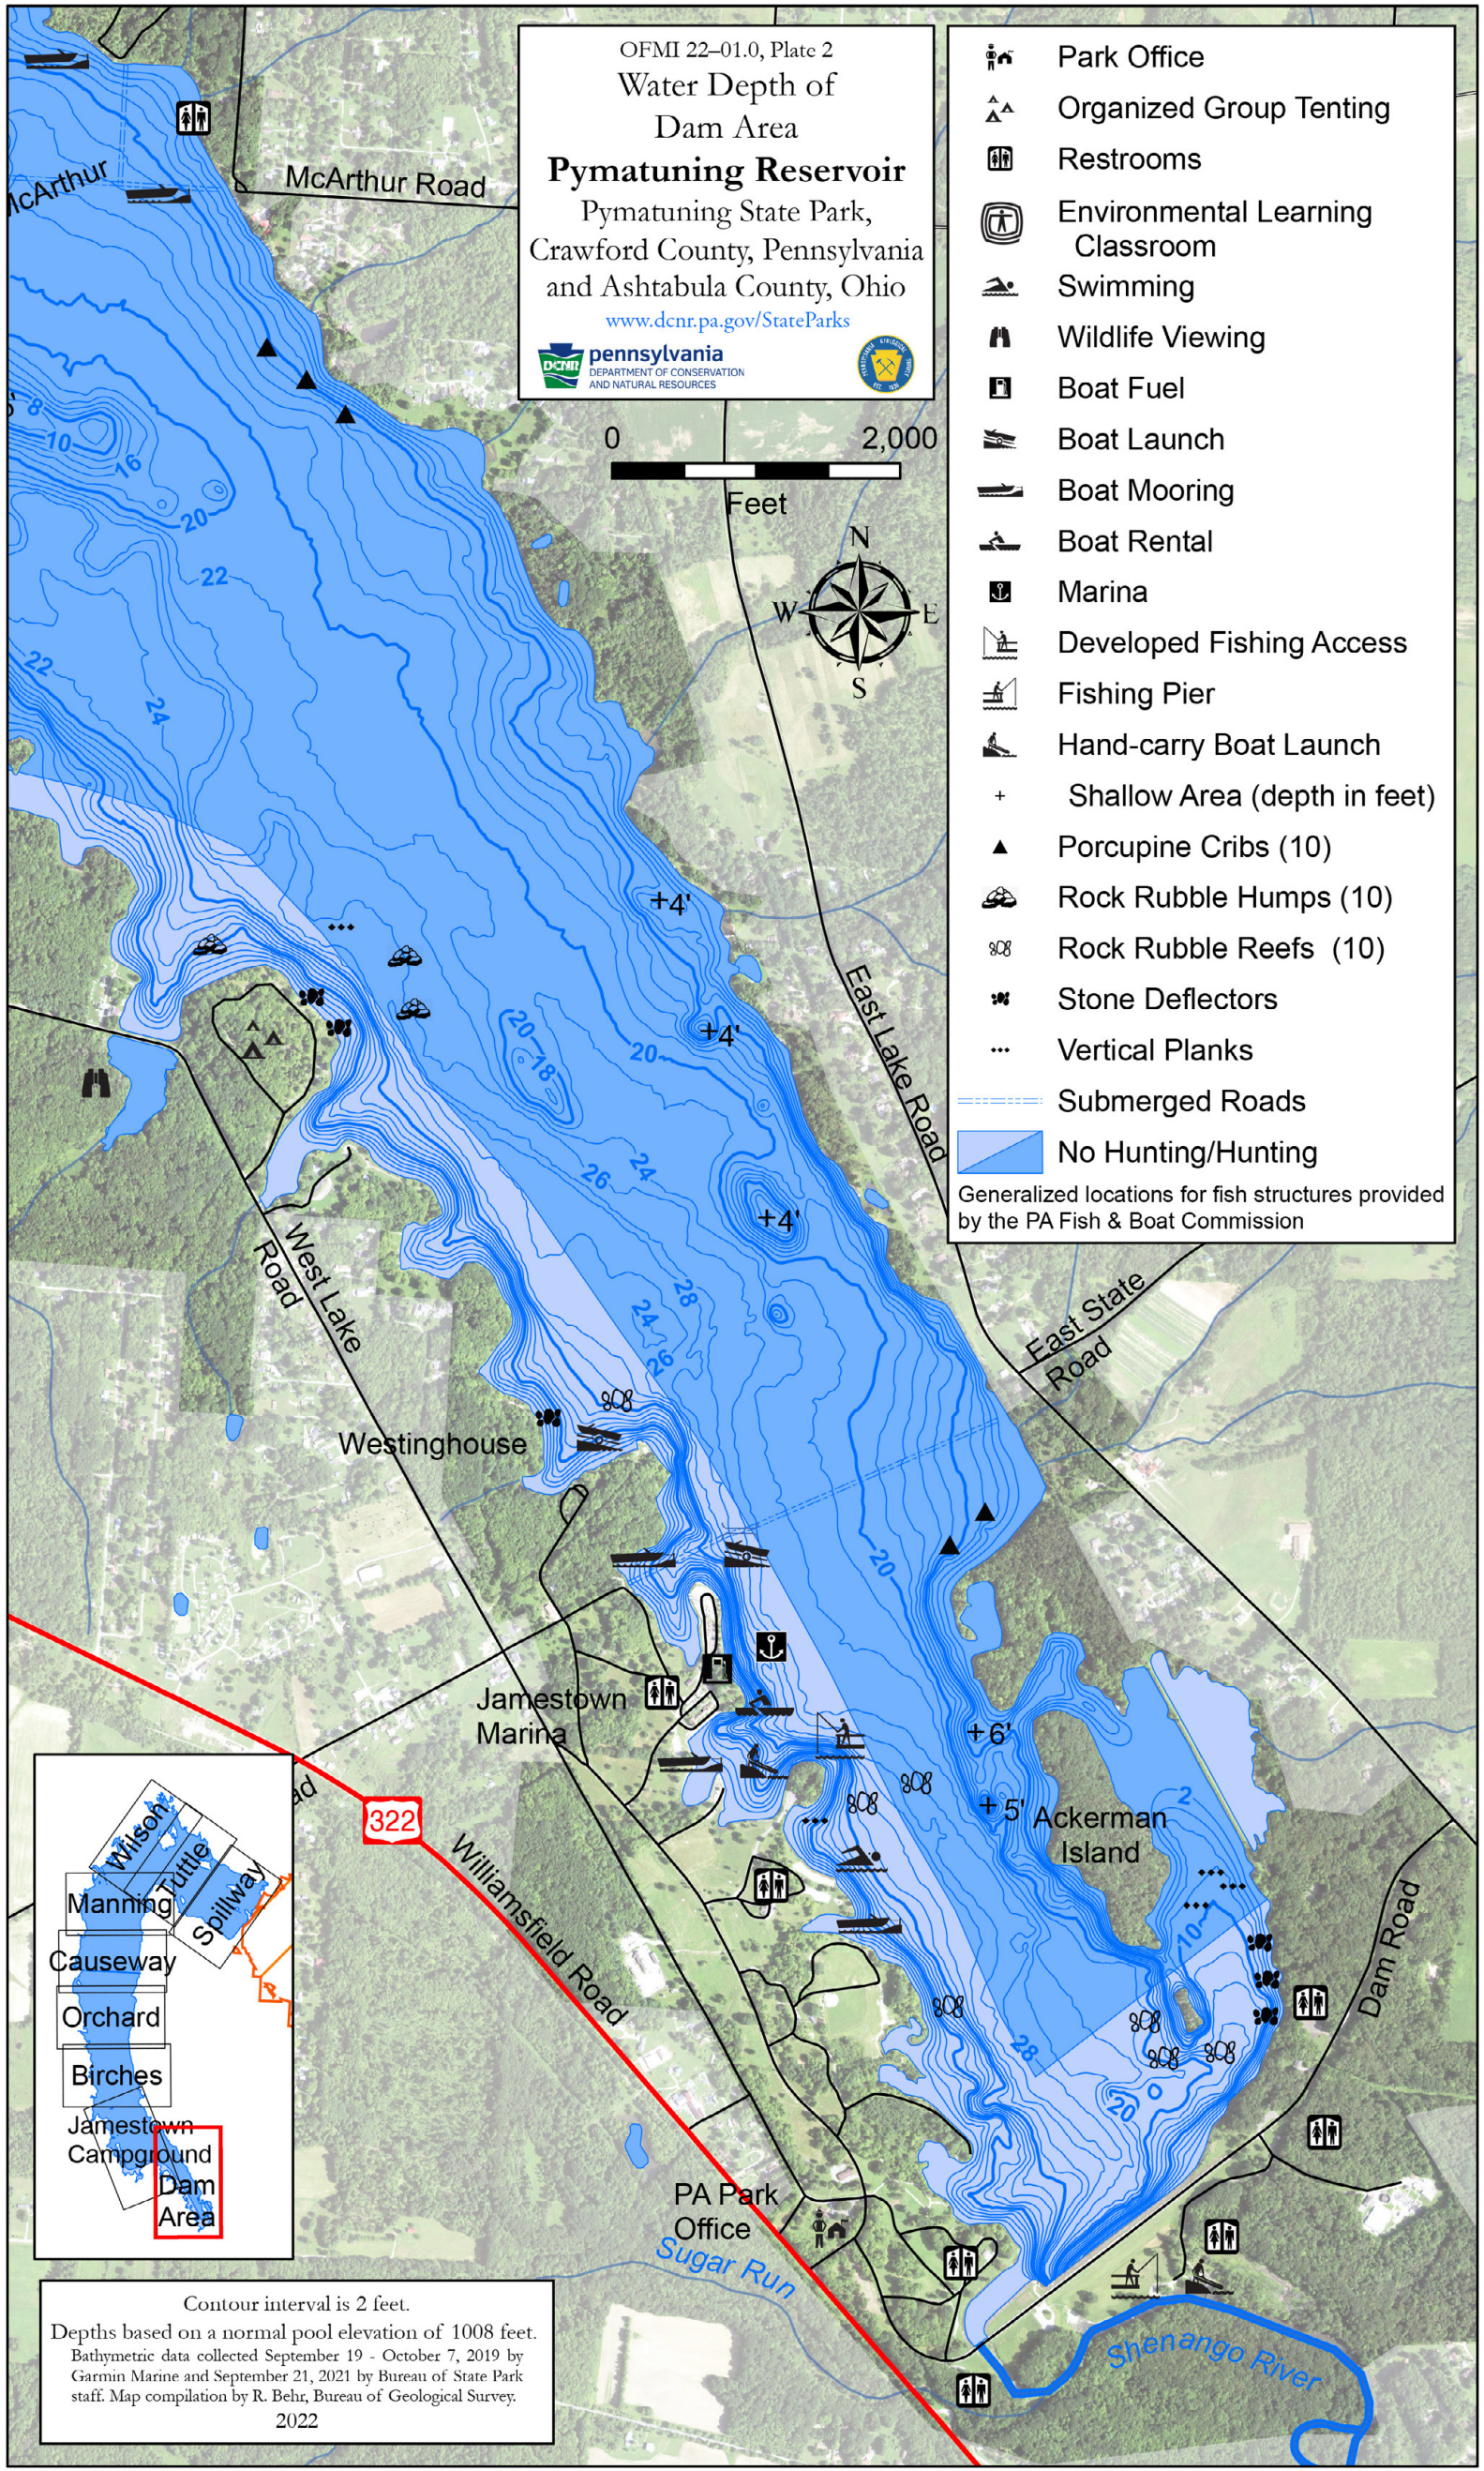
OFMI 22-01.0, Plate 2  
Water Depth of  
Dam Area  
**Pymatuning Reservoir**  
Pymatuning State Park,  
Crawford County, Pennsylvania  
and Ashtabula County, Ohio  
[www.dcnr.pa.gov/StateParks](http://www.dcnr.pa.gov/StateParks)

Contour interval is 2 feet.  
Depths based on a normal pool elevation of 1008 feet.  
Bathymetric data collected September 19 - October 7, 2019 by  
Garmin Marine and September 21, 2021 by Bureau of State Park  
staff. Map compilation by R. Behr, Bureau of Geological Survey.  
2022
