OFMI 22-01.0, Plate 1
Water Depth of
Pymatuning Reservoir
Pymatuning State Park,
Crawford County, Pennsylvania
and
Ashtabula County, Ohio
www.dcnr.pa.gov/StatePark

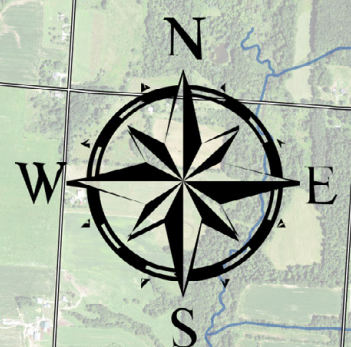
Pymatuning Reservoir contour interval is 5 feet and normal pool elevation is 1008 feet.
Sanctuary Lake contour interval is 2 feet and normal pool elevation is 1010 feet.
Bathymetric data collected September 19 - October 7, 2019 by Garmin Marine and September 21, 2021 by Bureau of State Park staff. Map compilation by R. Behr, Bureau of Geological Survey.
Base map is 2019 NAIP orthophotography.
