OFMI 15–19.0, Plate 3 Water Depth of Dowdy Hole Foster Joseph Sayers Lake Bald Eagle State Park, Centre County, Pennsylvania visitPAparks.com

OFMI 15–19.0, Plate 3 Water Depth of Upper Greens Run Foster Joseph Sayers Lake Bald Eagle State Park, Centre County, Pennsylvania visitPAparks.com

OFMI 15–19.0, Plate 3 Water Depth of Marina Foster Joseph Sayers Lake Bald Eagle State Park, Centre County, Pennsylvania visitPAparks.com

OFMI 15–19.0, Plate 3 Water Depth of Dam Area Foster Joseph Sayers Lake Bald Eagle State Park, Centre County, Pennsylvania visitPAparks.com

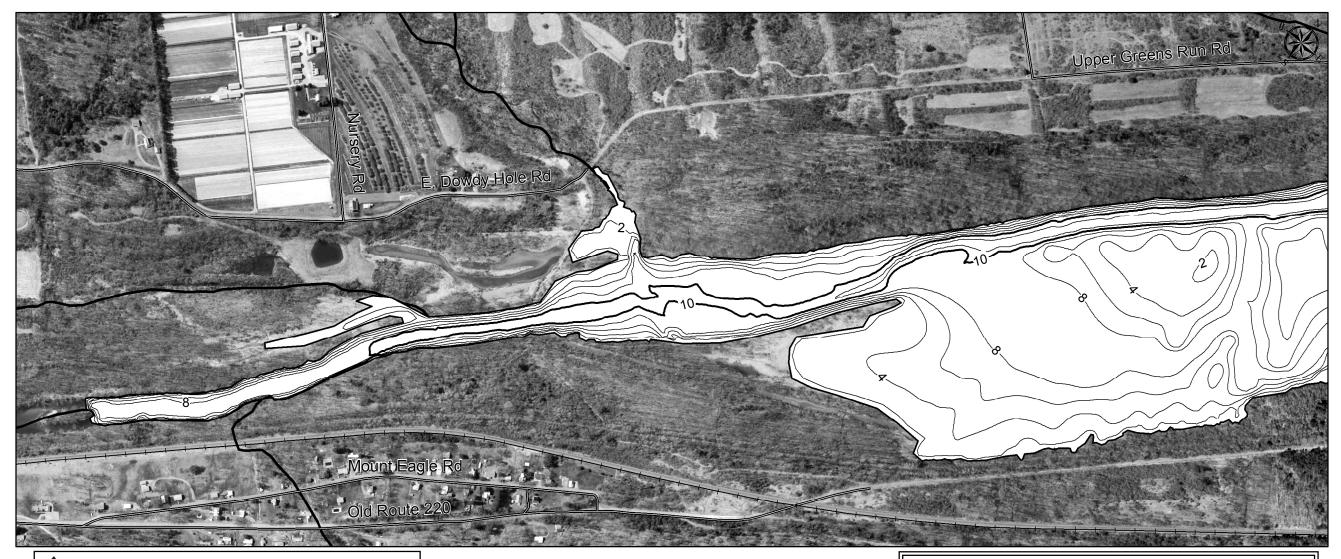
Contour interval is 2 feet.

Bathymetric data collected October 30 to November 1, 2007 by R. Behr, Bureau of Topographic and Geologic Survey, and D. Terrell of the U.S. Geological Survey. Data processing and map compilation by M. Moore and R. Behr, Bureau of Topographic and Geologic Survey. Base map is PAMAP orthophotography.

Depths based on normal pool elevation of 630 feet above sea level. April 2015

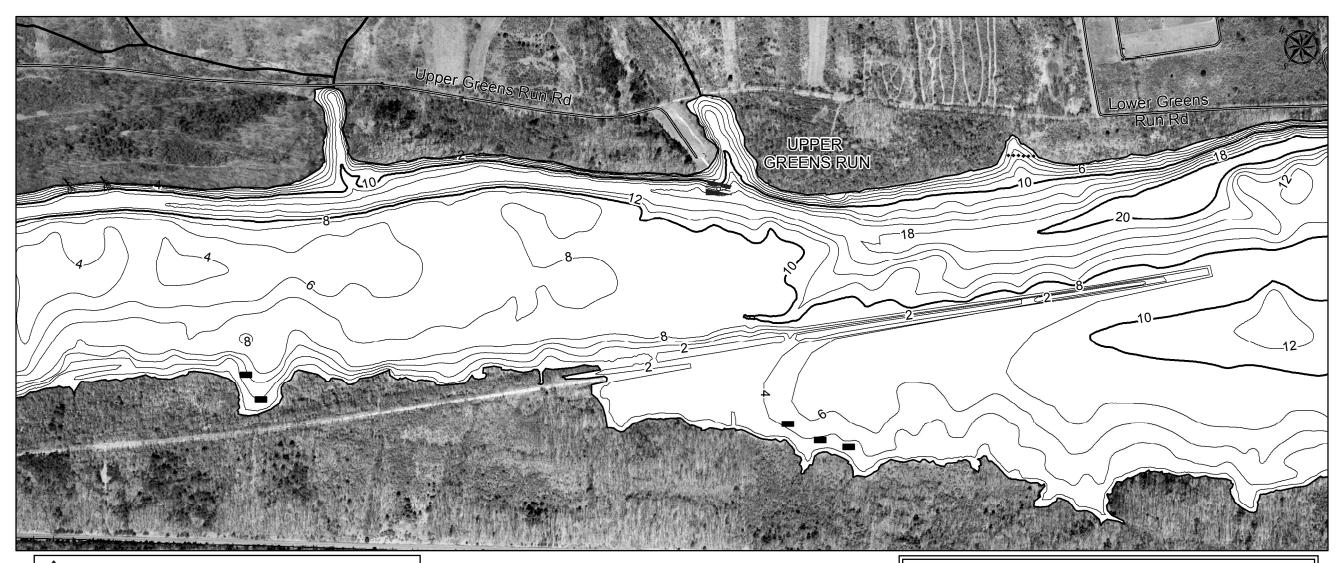
Contour interval is 2 feet.

Bathymetric data collected October 30 to November 1, 2007 by R. Behr, Bureau of Topographic and Geologic Survey, and D. Terrell of the U.S. Geological Survey. Data processing and map compilation by M. Moore and R. Behr, Bureau of Topographic and Geologic Survey. Base map is PAMAP orthophotography.

Depths based on normal pool elevation of 630 feet above sea level. April 2015

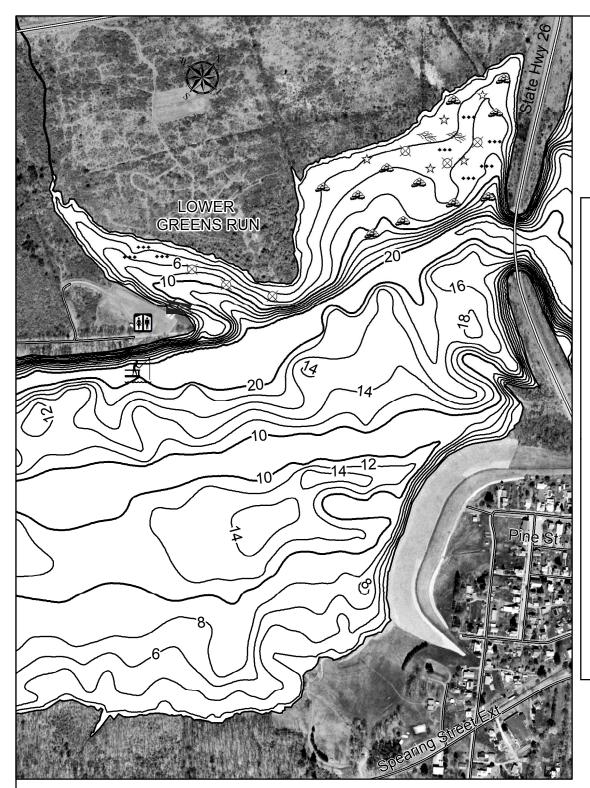
OFMI 15–19.0, Plate 3
Water Depth of Lower Greens Run
Foster Joseph Sayers Lake
Bald Eagle State Park,
Centre County, Pennsylvania
visitPAparks.com

Contour interval is 2 feet.

Bathymetric data collected October 30 to November 1, 2007 by R. Behr, Bureau of Topographic and Geologic Survey, and D. Terrell of the U.S. Geological Survey. Data processing and map compilation by M. Moore and R. Behr, Bureau of Topographic and Geologic Survey. Base map is PAMAP orthophotography.

Depths based on normal pool elevation of 630 feet above sea level.

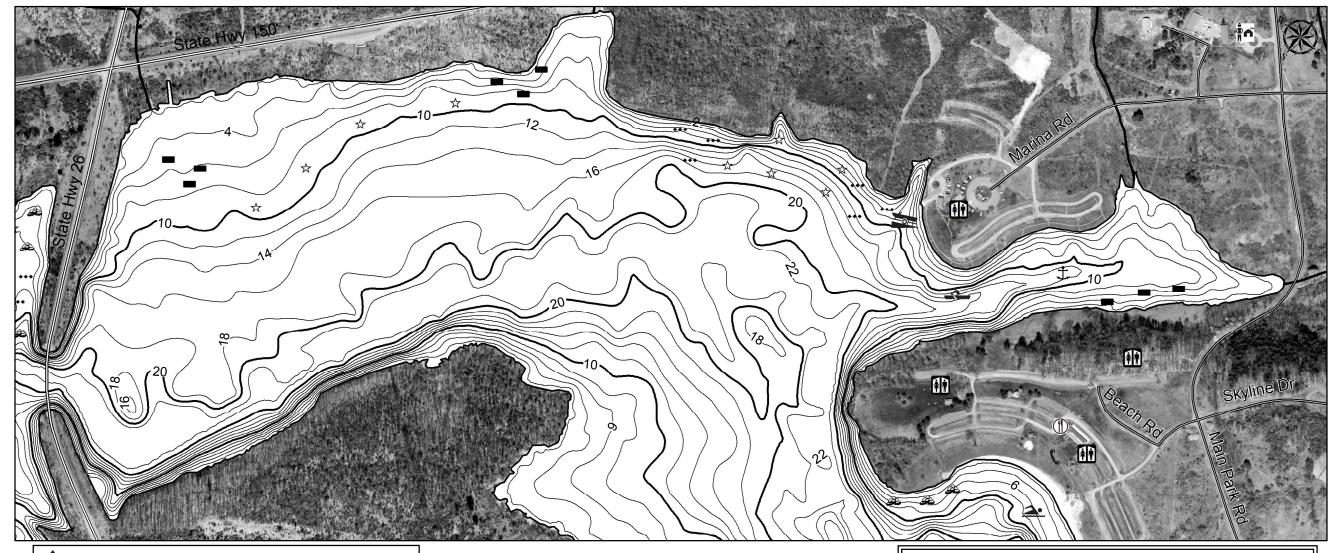
Contour interval is 2 feet.

Bathymetric data collected October 30 to November 1, 2007 by R. Behr, Bureau of Topographic and Geologic Survey, and D. Terrell of the U.S. Geological Survey. Data processing and map compilation by M. Moore and R. Behr, Bureau of Topographic and Geologic Survey. Base map is PAMAP orthophotography.

Depths based on normal pool elevation of 630 feet above sea level. April 2015

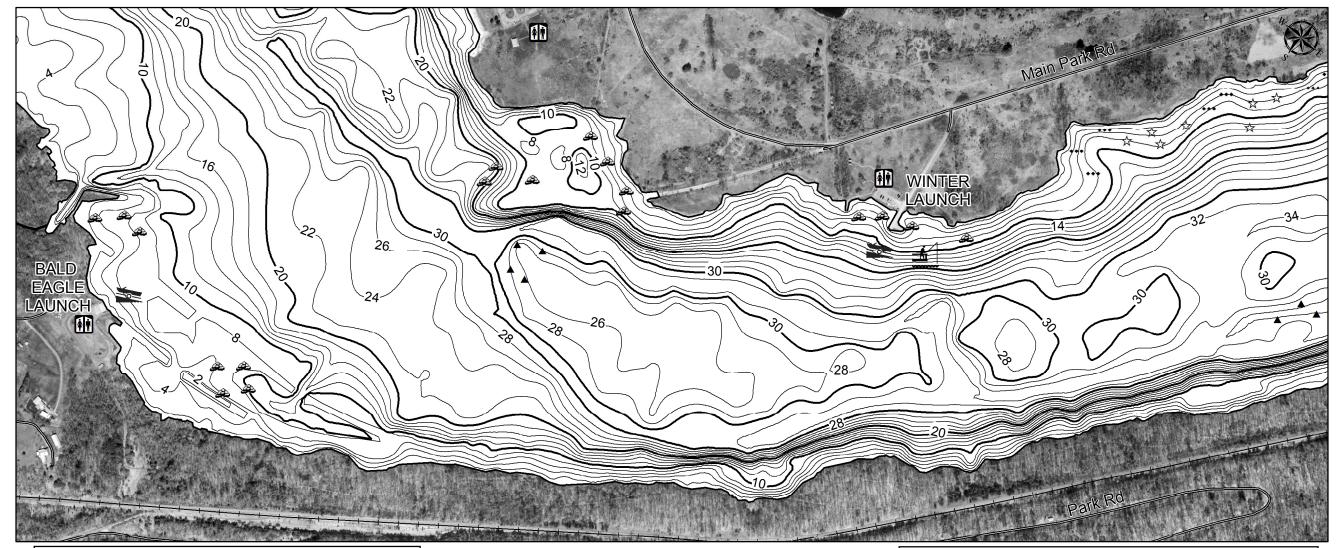
Contour interval is 2 feet.

Bathymetric data collected October 30 to November 1, 2007 by R. Behr, Bureau of Topographic and Geologic Survey, and D. Terrell of the U.S. Geological Survey. Data processing and map compilation by M. Moore and R. Behr, Bureau of Topographic and Geologic Survey. Base map is PAMAP orthophotography.

Depths based on normal pool elevation of 630 feet above sea level. April 2015 OFMI 15–19.0, Plate 3
Water Depth of Winter Launch
Foster Joseph Sayers Lake
Bald Eagle State Park,
Centre County, Pennsylvania
visitPAparks.com

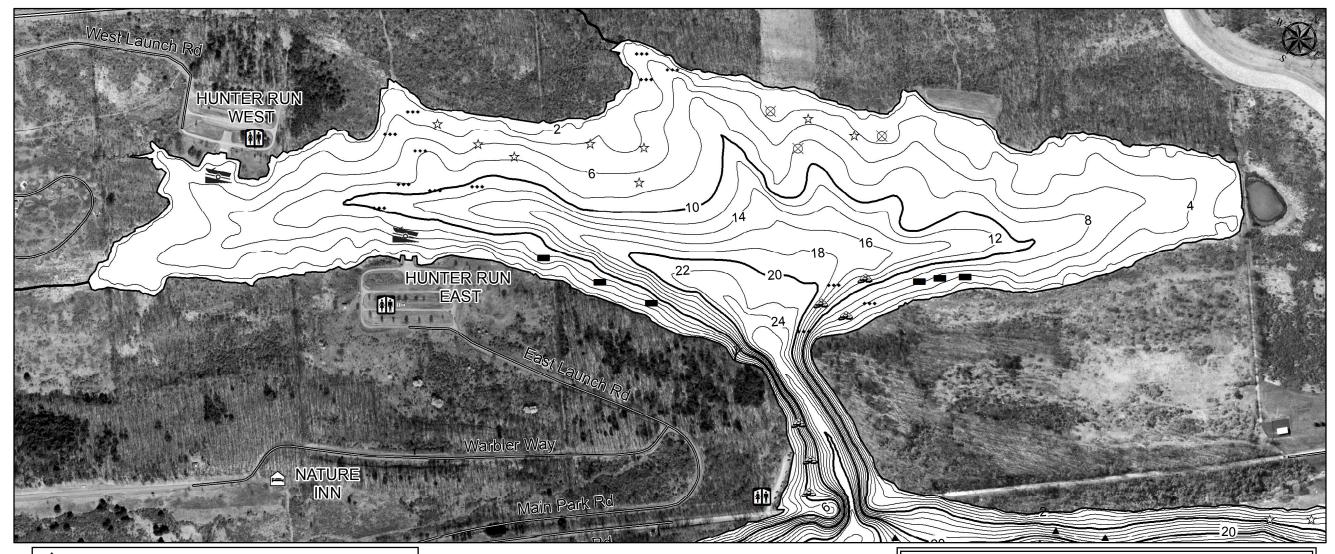
Water Depth of Hunter Run Foster Joseph Sayers Lake Bald Eagle State Park, Centre County, Pennsylvania visitPAparks.com

Contour interval is 2 feet.

Bathymetric data collected October 30 to November 1, 2007 by R. Behr, Bureau of Topographic and Geologic Survey, and D. Terrell of the U.S. Geological Survey. Data processing and map compilation by M. Moore and R. Behr, Bureau of Topographic and Geologic Survey. Base map is PAMAP orthophotography.

Depths based on normal pool elevation of 630 feet above sea level. April 2015

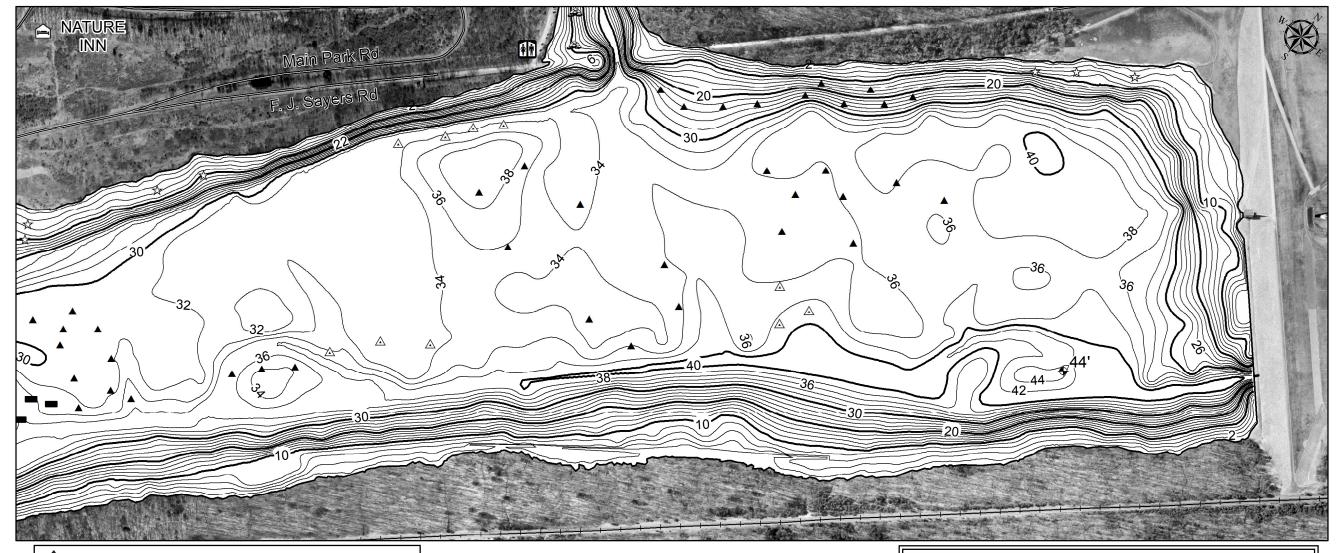
Contour interval is 2 feet.

Bathymetric data collected October 30 to November 1, 2007 by R. Behr, Bureau of Topographic and Geologic Survey, and D. Terrell of the U.S. Geological Survey. Data processing and map compilation by M. Moore and R. Behr, Bureau of Topographic and Geologic Survey. Base map is PAMAP orthophotography.

Depths based on normal pool elevation of 630 feet above sea level. April 2015
