OFMI 19-04.1, Plate 3

Water Depth of
Dam Area

East Branch Lake

Elk State Park,
Elk County, Pennsylvania

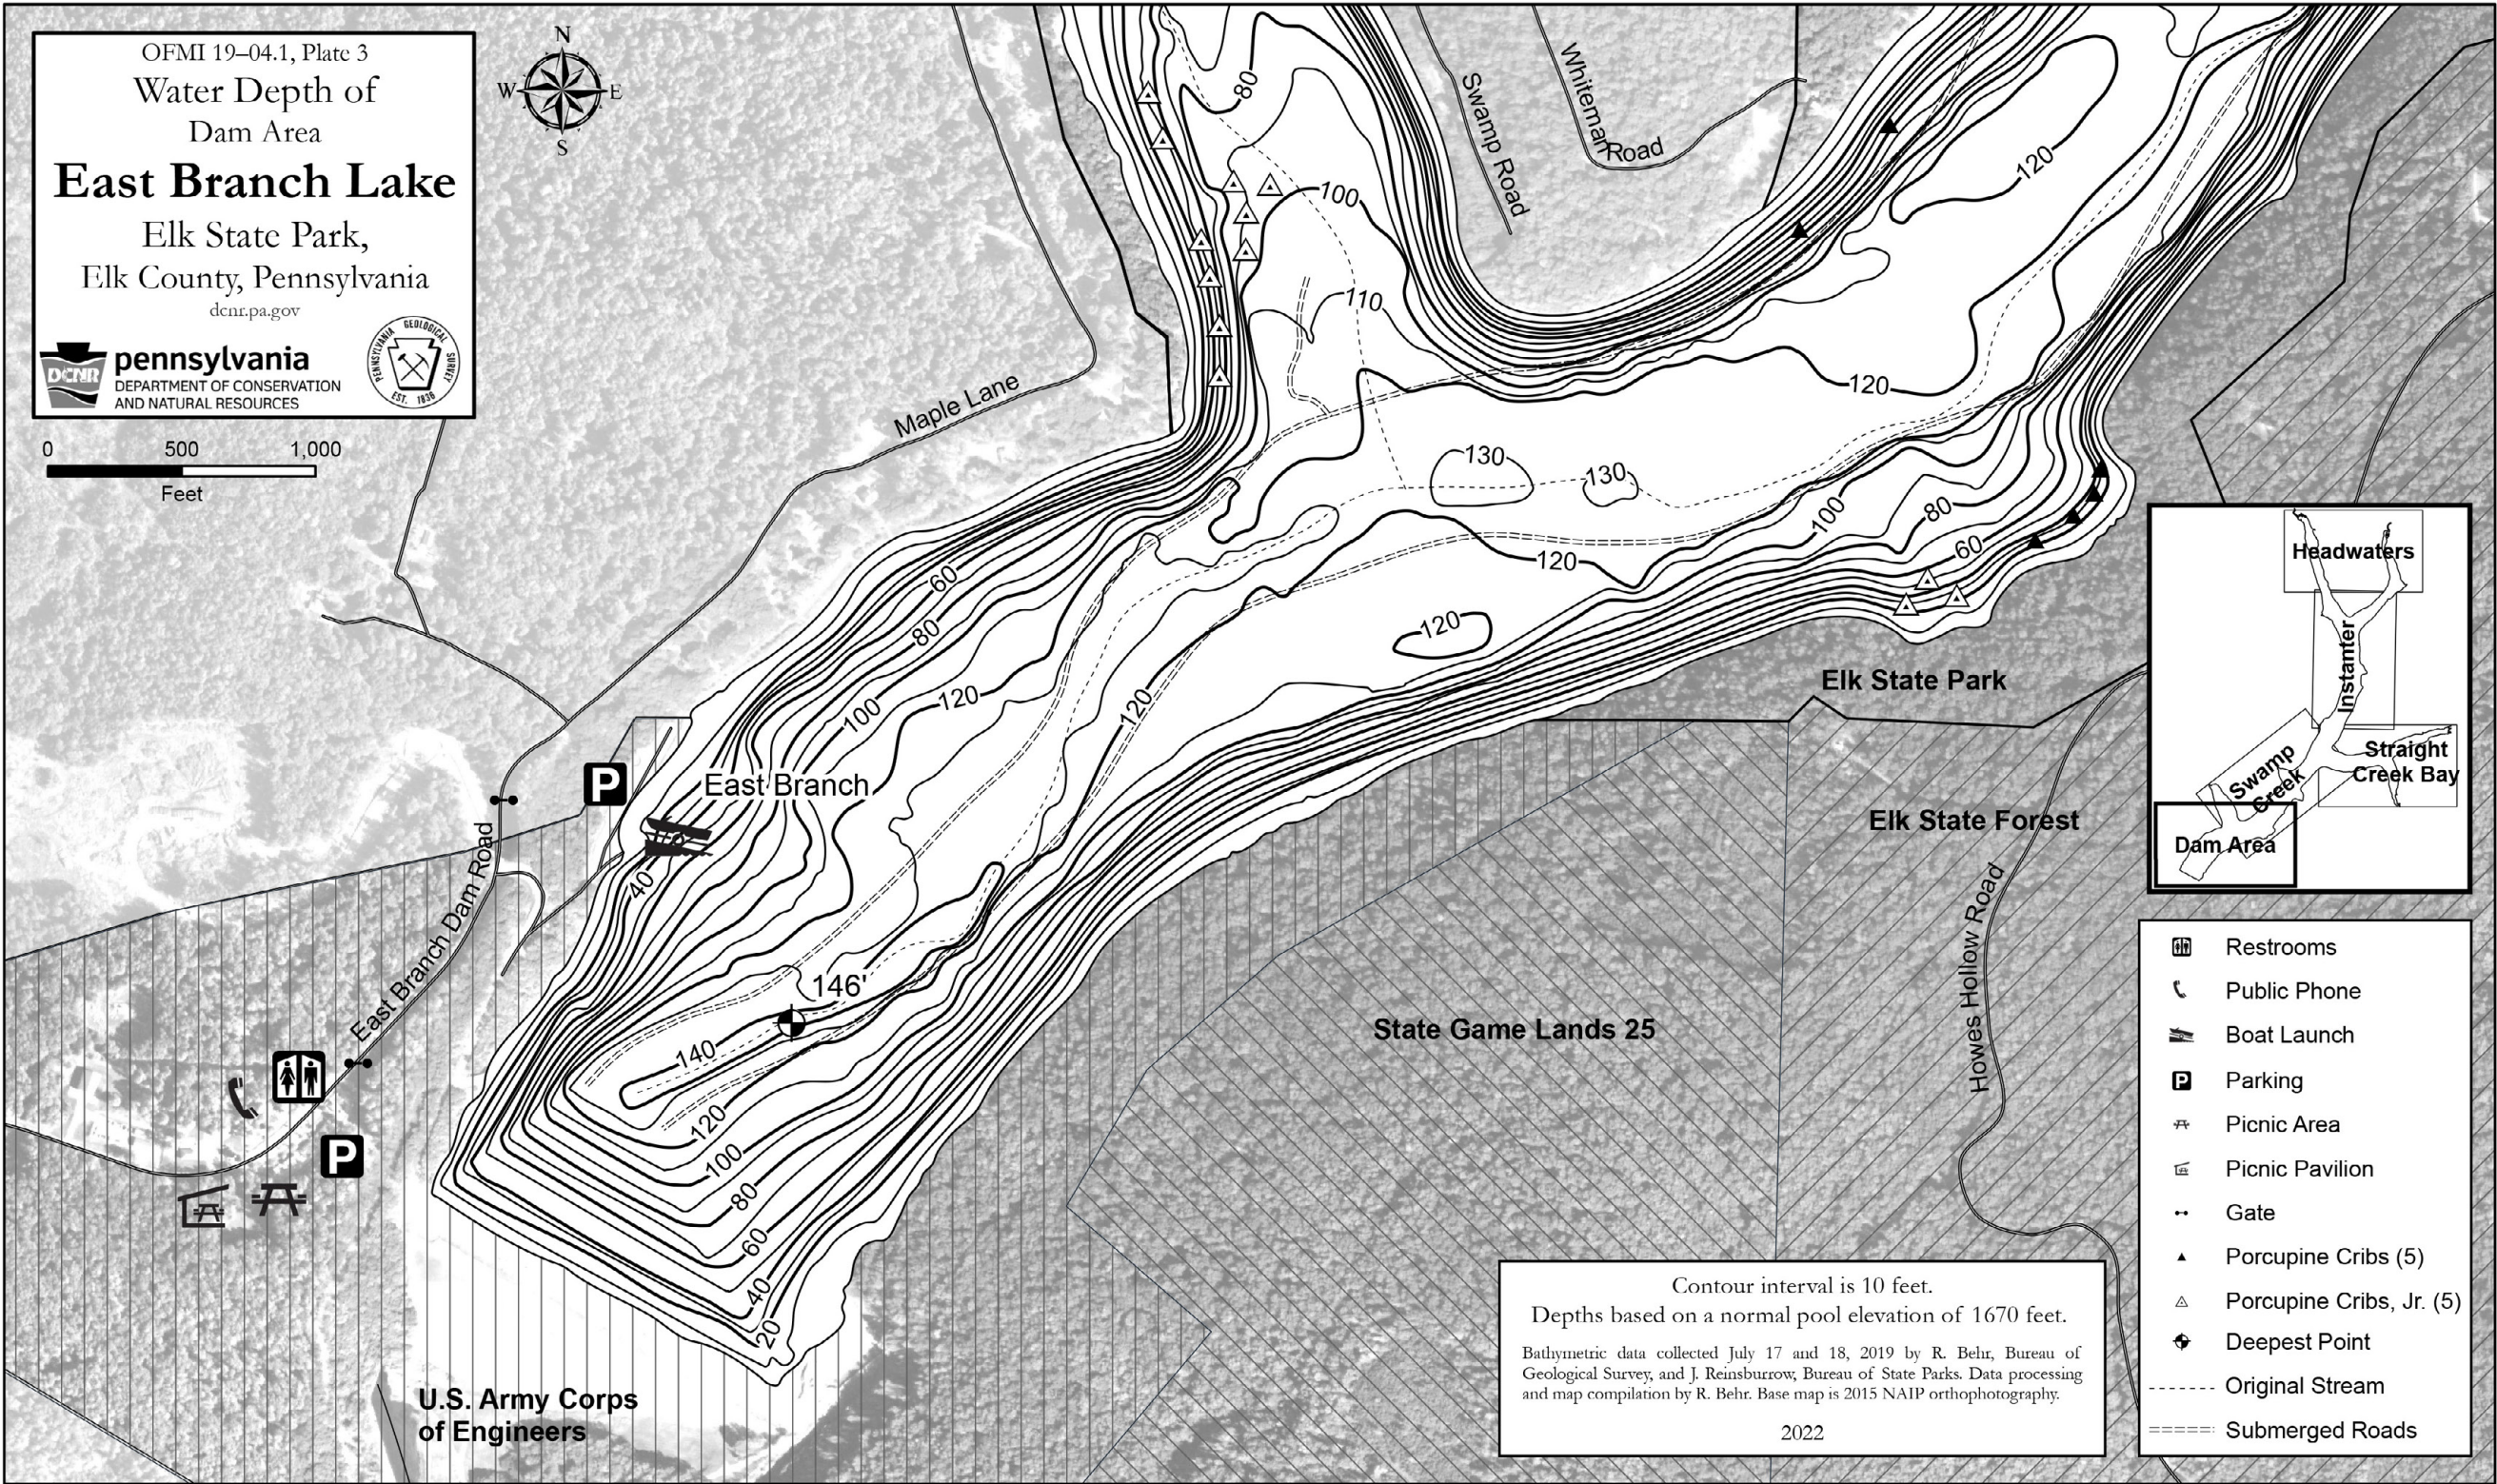
Contour interval is 10 feet.

Depths based on a normal pool elevation of 1670 feet.

Bathymetric data collected July 17 and 18, 2019 by R. Behr, Bureau of Geological Survey, and J. Reinsburrow, Bureau of State Parks. Data processing and map compilation by R. Behr. Base map is 2015 NAIP orthophotography.

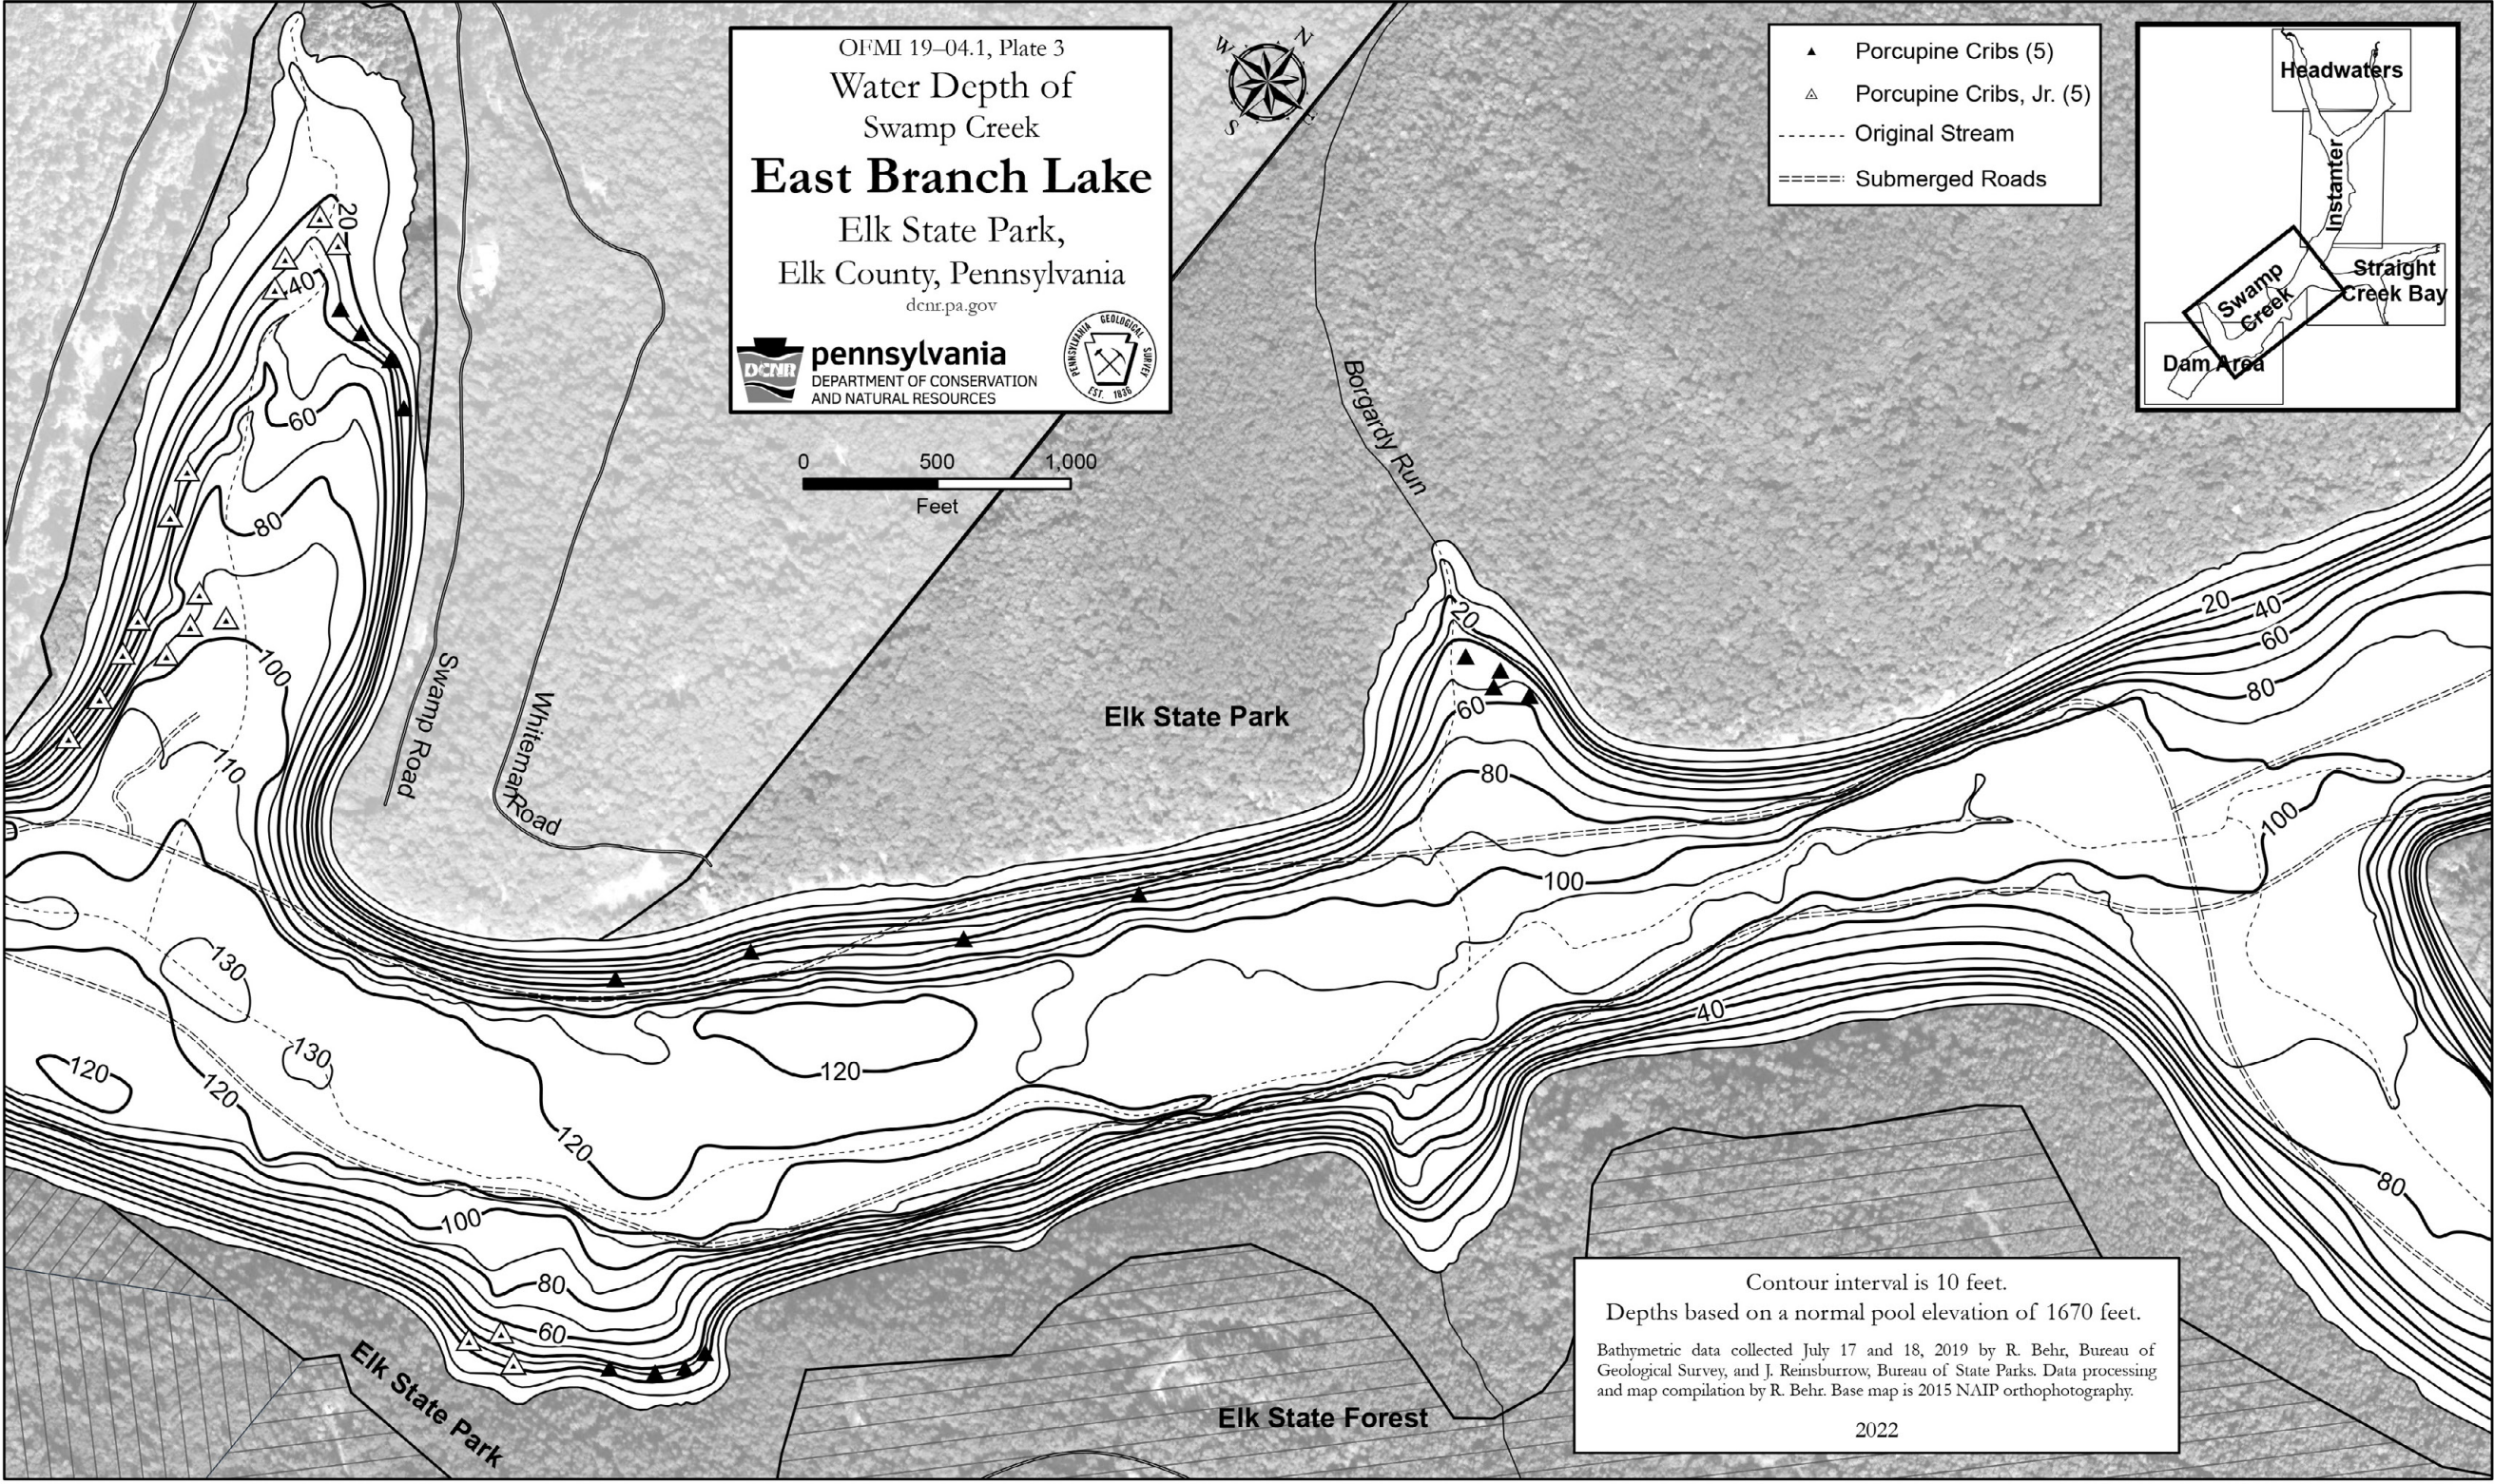
Water Depth of
Instanter

Contour interval is 10 feet.

Depths based on a normal pool elevation of 1670 feet.

Bathymetric data collected July 17 and 18, 2019 by R. Behr, Bureau of Geological Survey, and J. Reinsburrow, Bureau of State Parks. Data processing and map compilation by R. Behr. Base map is 2015 NAIP orthophotography.

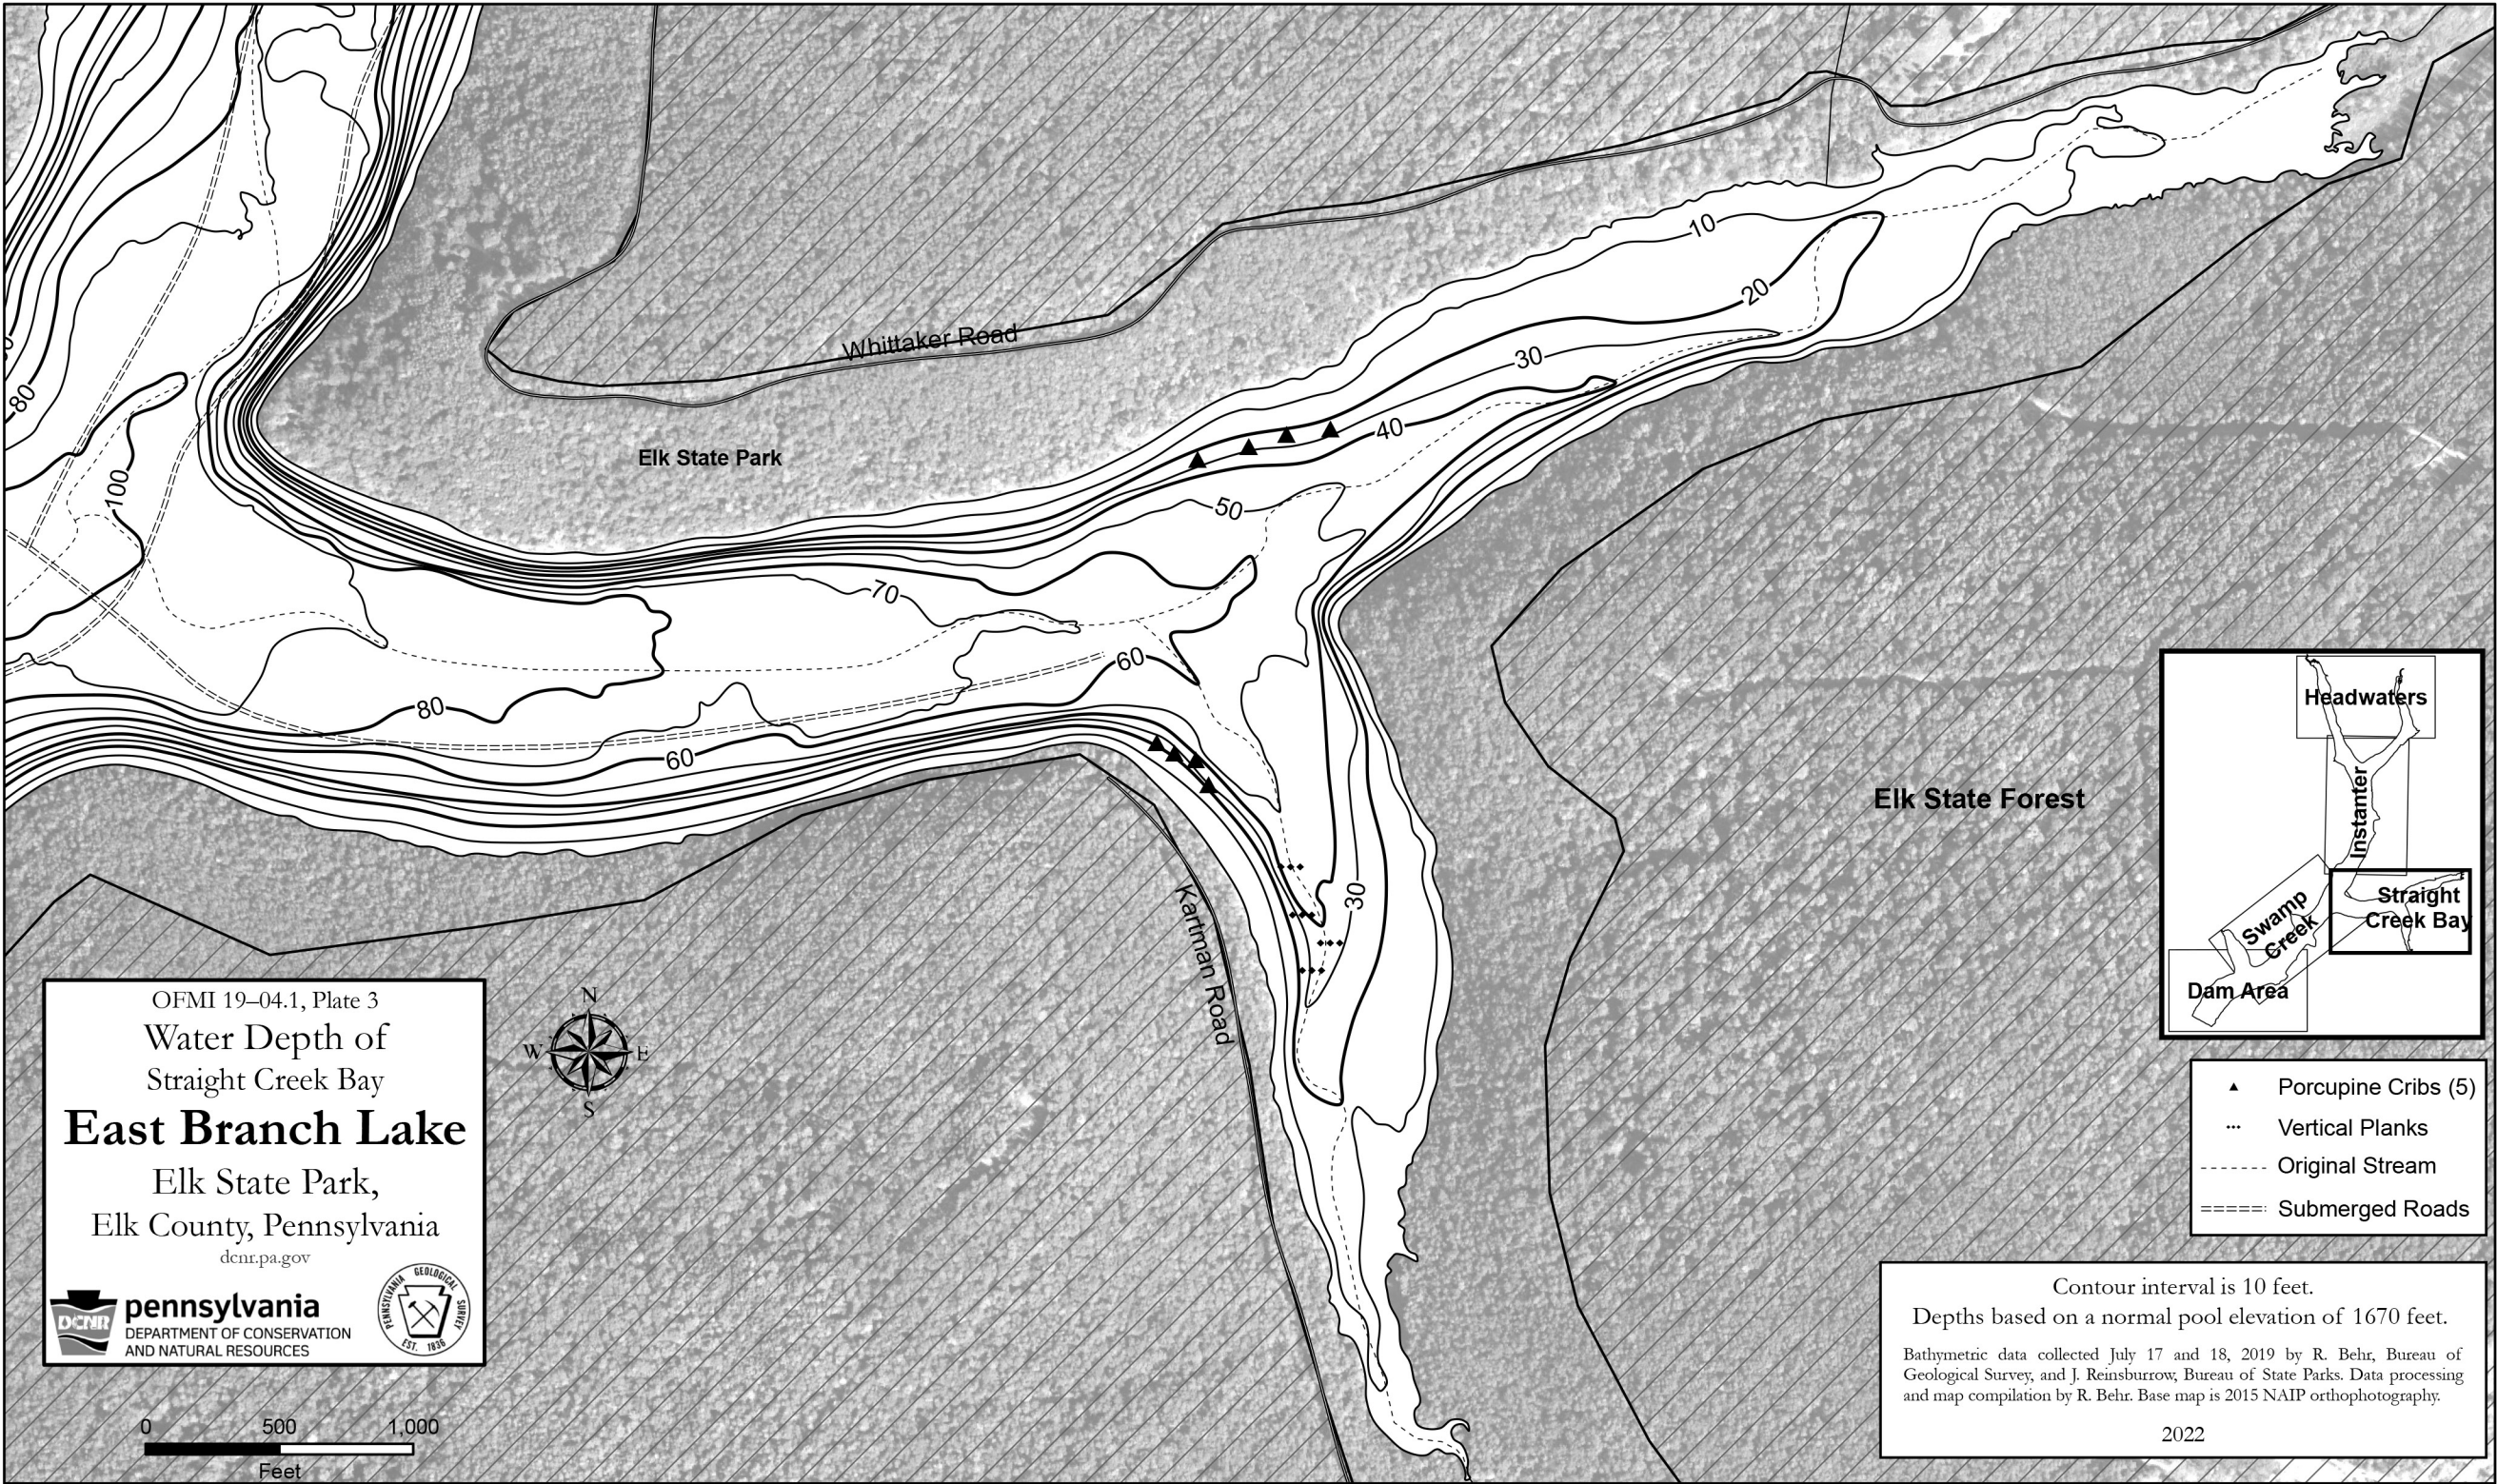
OFMI 19-04.1, Plate 3
Water Depth of
Straight Creek Bay
East Branch Lake
Elk State Park,
Elk County, Pennsylvania
dcmr.pa.gov

Contour interval is 10 feet.
Depths based on a normal pool elevation of 1670 feet.
Bathymetric data collected July 17 and 18, 2019 by R. Behr, Bureau of Geological Survey, and J. Reinsburrow, Bureau of State Parks. Data processing and map compilation by R. Behr. Base map is 2015 NAIP orthophotography.
2022

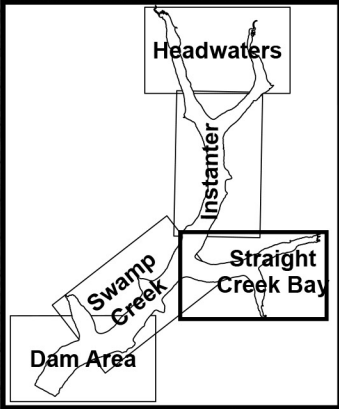
- ▲ Porcupine Cribs (5)
- ... Vertical Planks
- Original Stream
- ===== Submerged Roads

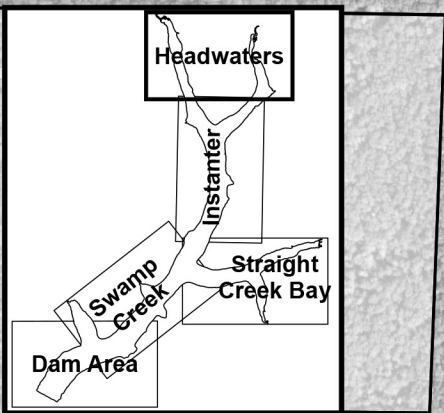
OFMI 19-04.1, Plate 3
Water Depth of
Headwaters
East Branch Lake
Elk State Park,
Elk County, Pennsylvania
dcnr.pa.gov

- Original Stream
- ===== Submerged Roads

Contour interval is 10 feet.
Depths based on a normal pool elevation of 1670 feet.
Bathymetric data collected July 17 and 18, 2019 by R. Behr, Bureau of Geological Survey, and J. Reinsburrow, Bureau of State Parks. Data processing and map compilation by R. Behr. Base map is 2015 NAIP orthophotography.
2022
